SUBJECT: Consideration of a request from the Vista Hills Homeowners Association for the City to accept Vista Hills streets contingent on City's receipt of Association's \$190,000 payment for the City to make required pavement and storm structure repairs.

Vista Hills Subdivision Pavement and Drainage Structure Evaluation

VISTA HILLS SUBDIVISION
PAVEMENT AND DRAINAGE STRUCTURE EVALUATION
PREPARED FOR THE
CITY OF NOVI

May, 2005
Project No. 230799.00.000

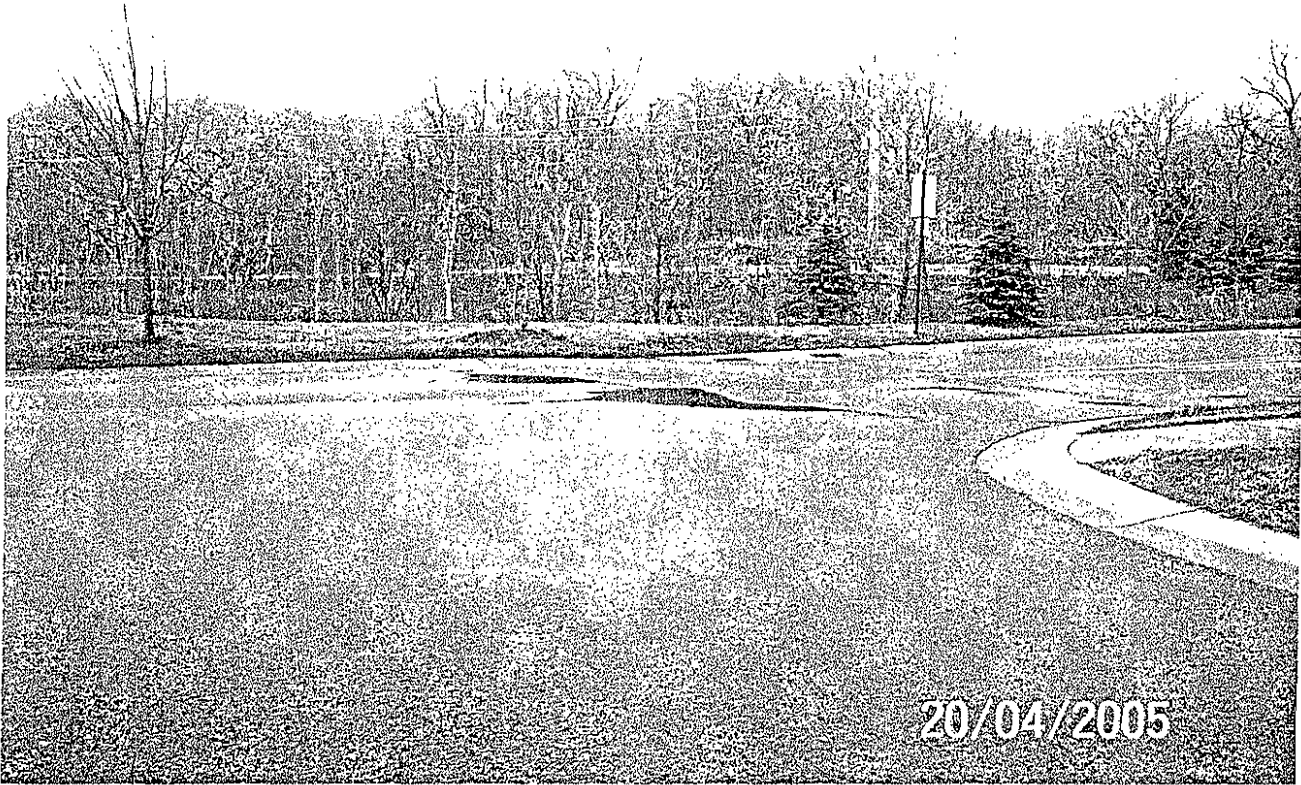
Sandstone west of Hearthstone
Heaved pavement is causing storm water to pond on street surface

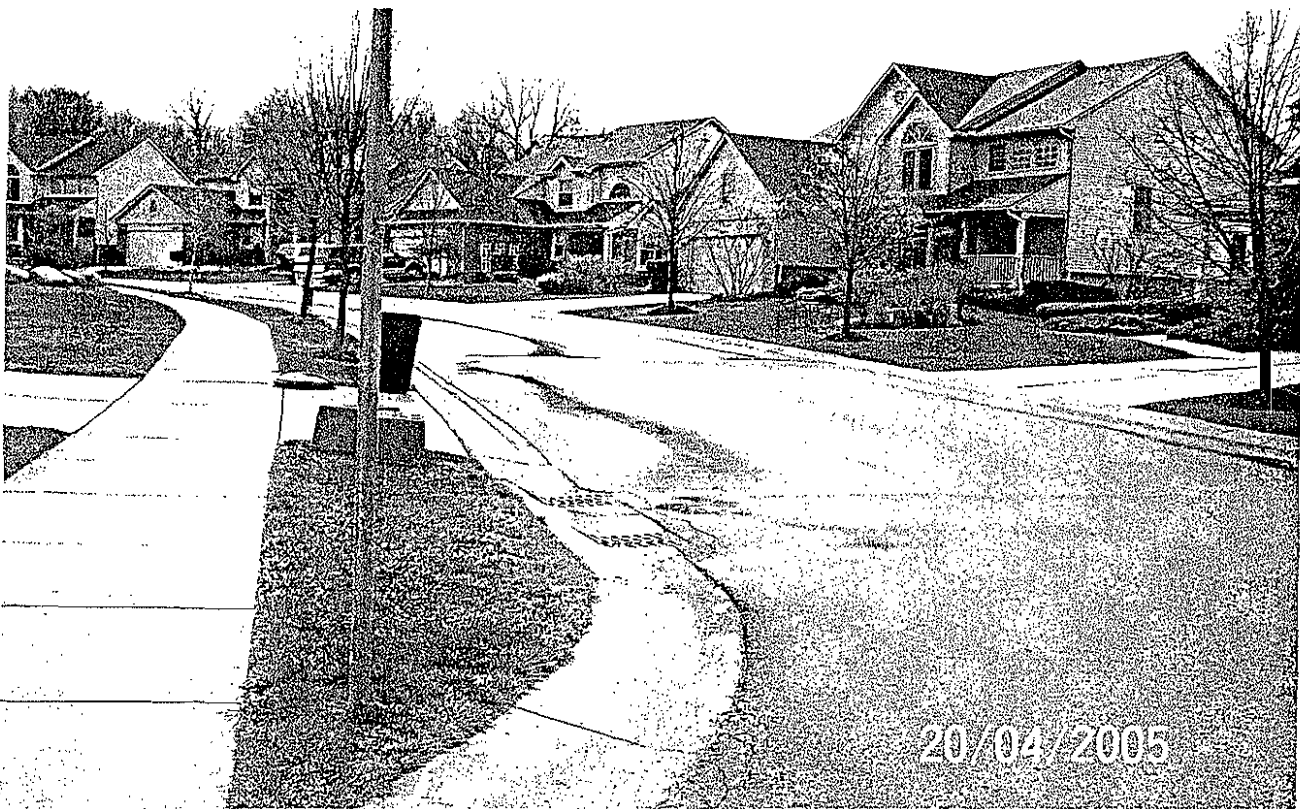
Sandstone east of Hearthstone
Heaved pavement is causing storm water to pond on road surface. Surface cracks have formed in location where pavement has heaved and at the catch basins.

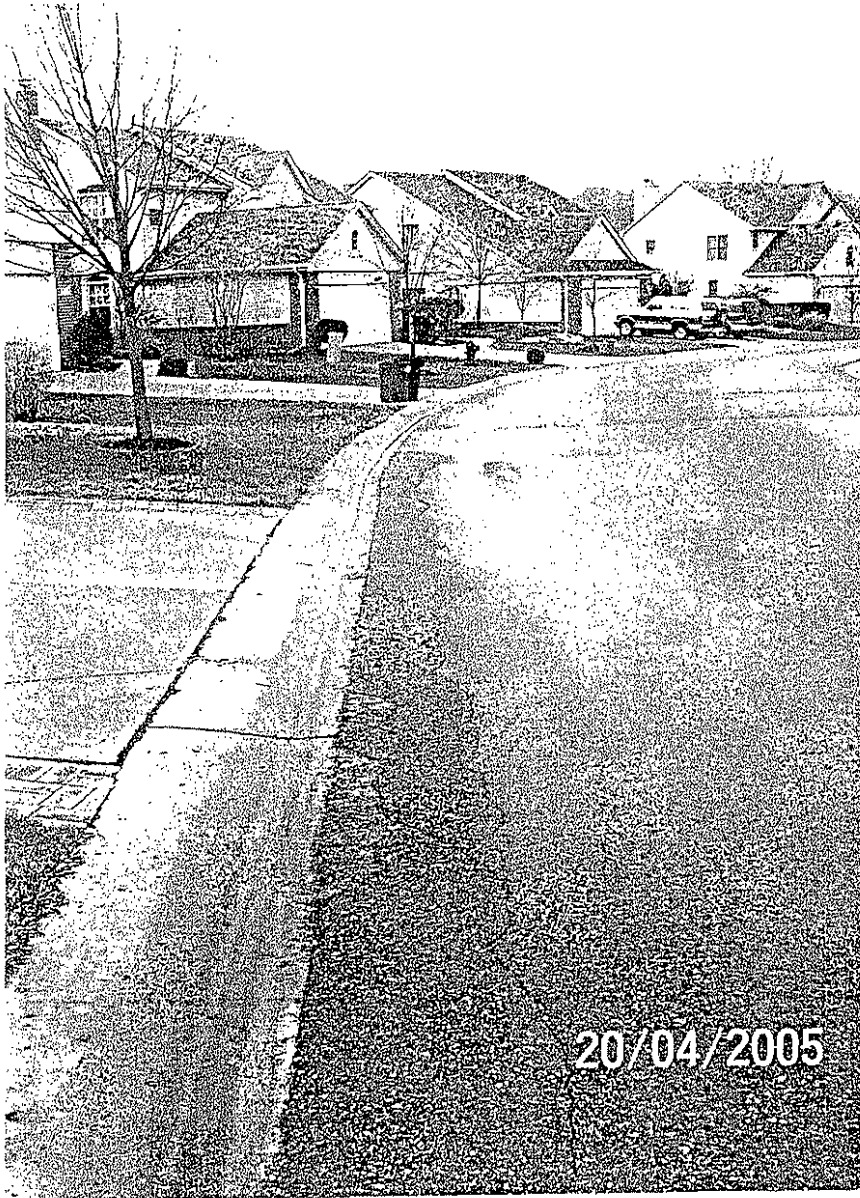
Sandstone at house no. 43137

Cracking at edge of metal.

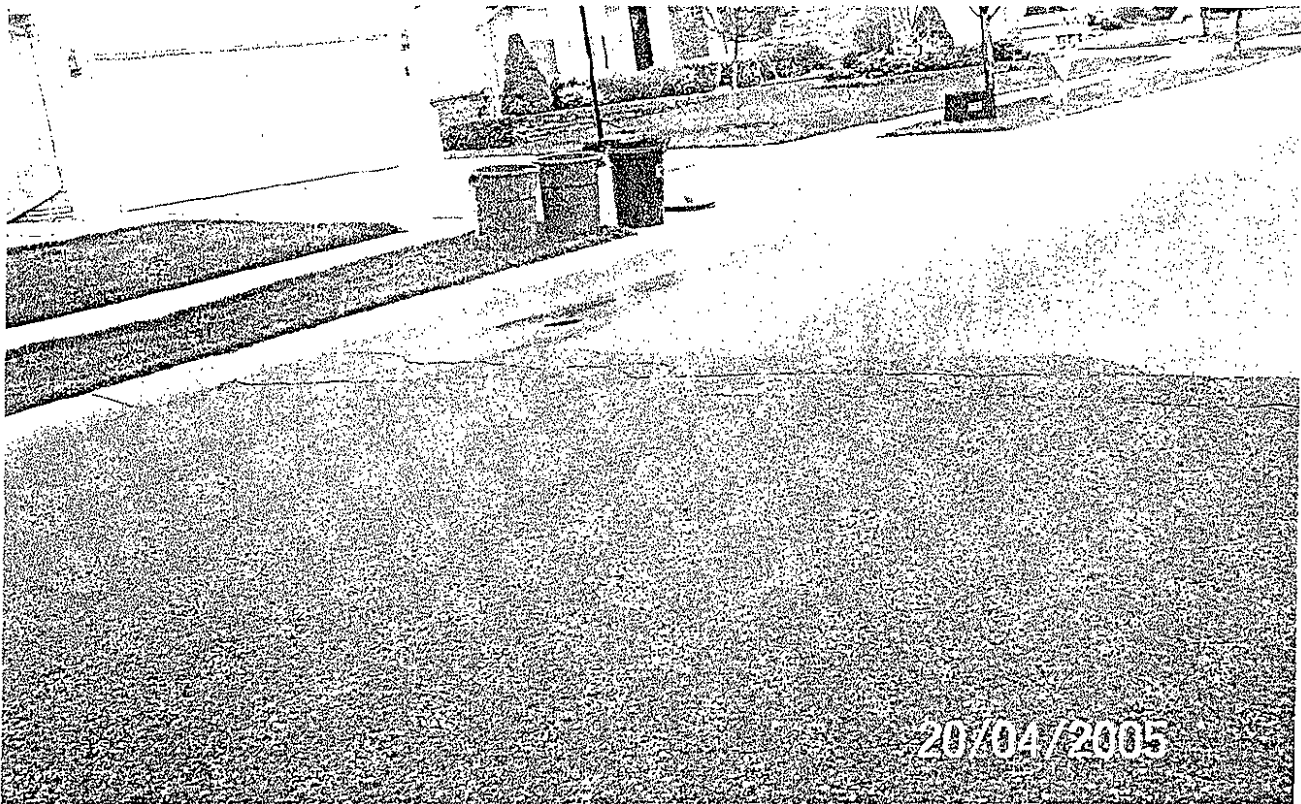
Sandstone at house no. 43116
Typical transverse cracking. Occurs frequently on this street at intervals of 100 ft. +/-

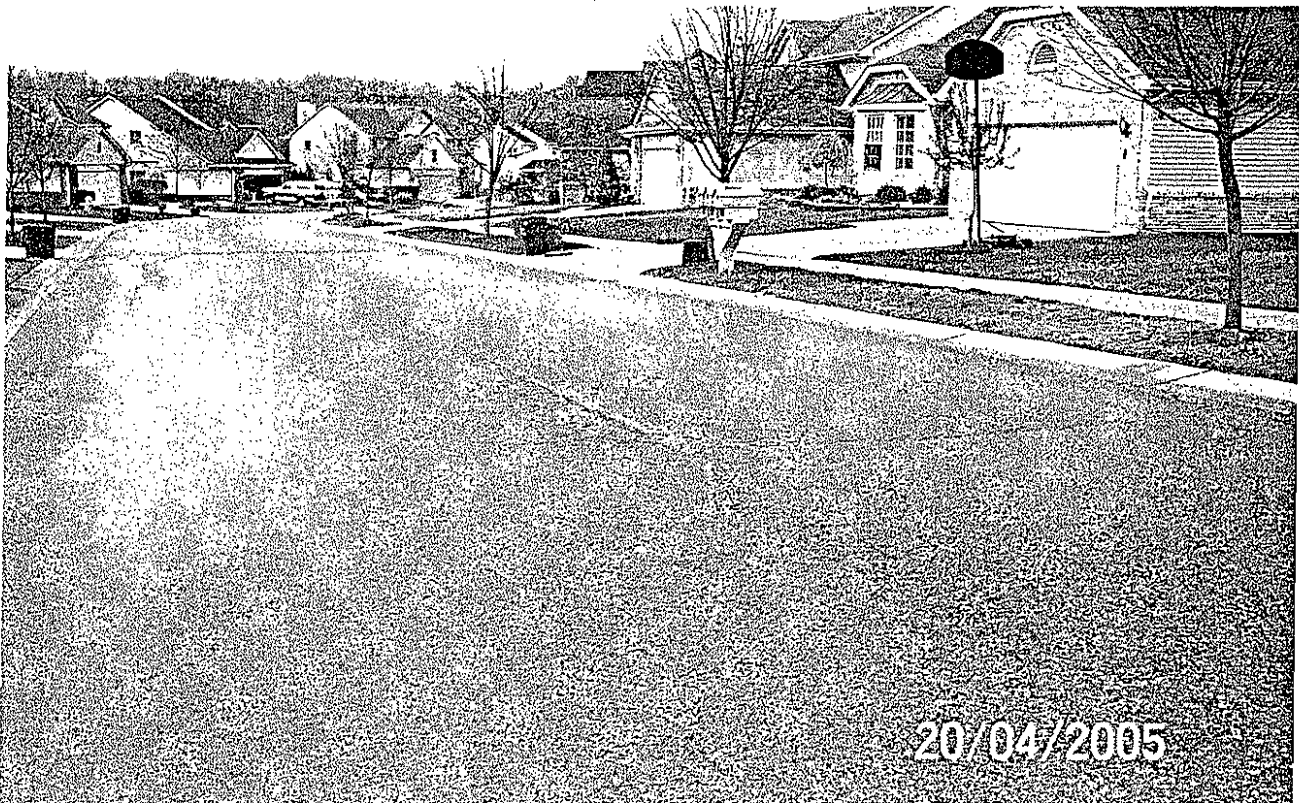
Sandstone at house no. 43094
Transverse and longitudinal cracking.

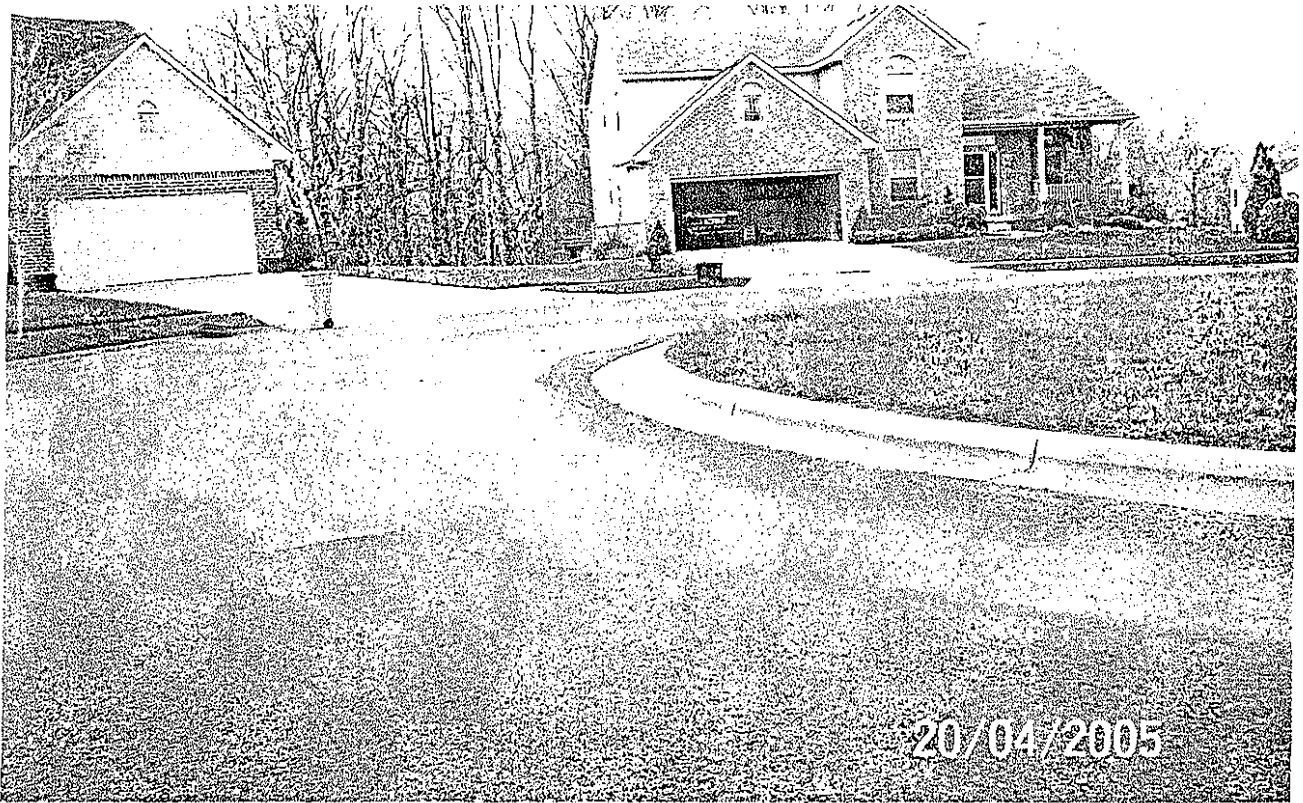
Quary Ct.
Cracks along cul-de-sac island edge of metal.

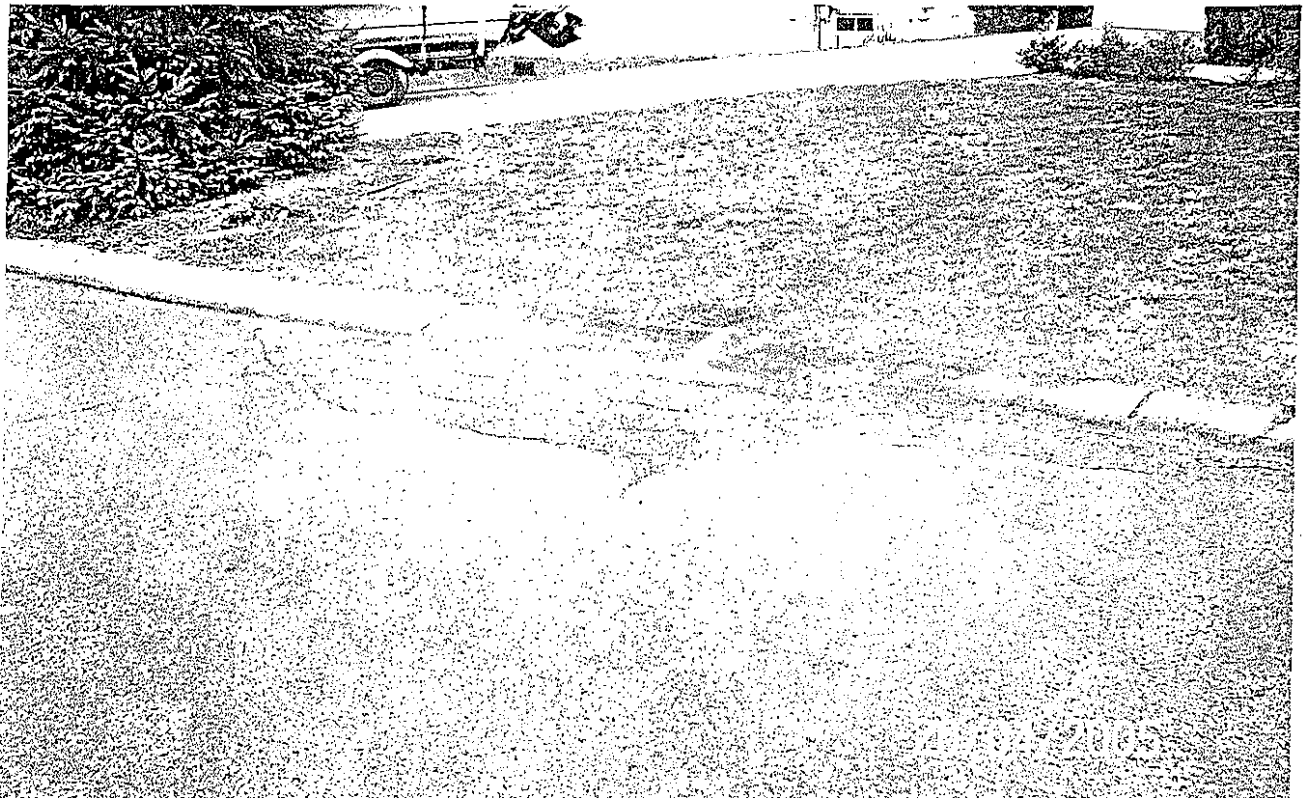
Quary Ct. at house no. 28738
Apparent low point in curbing. Sediment has built up in this location and edge cracking is evident.

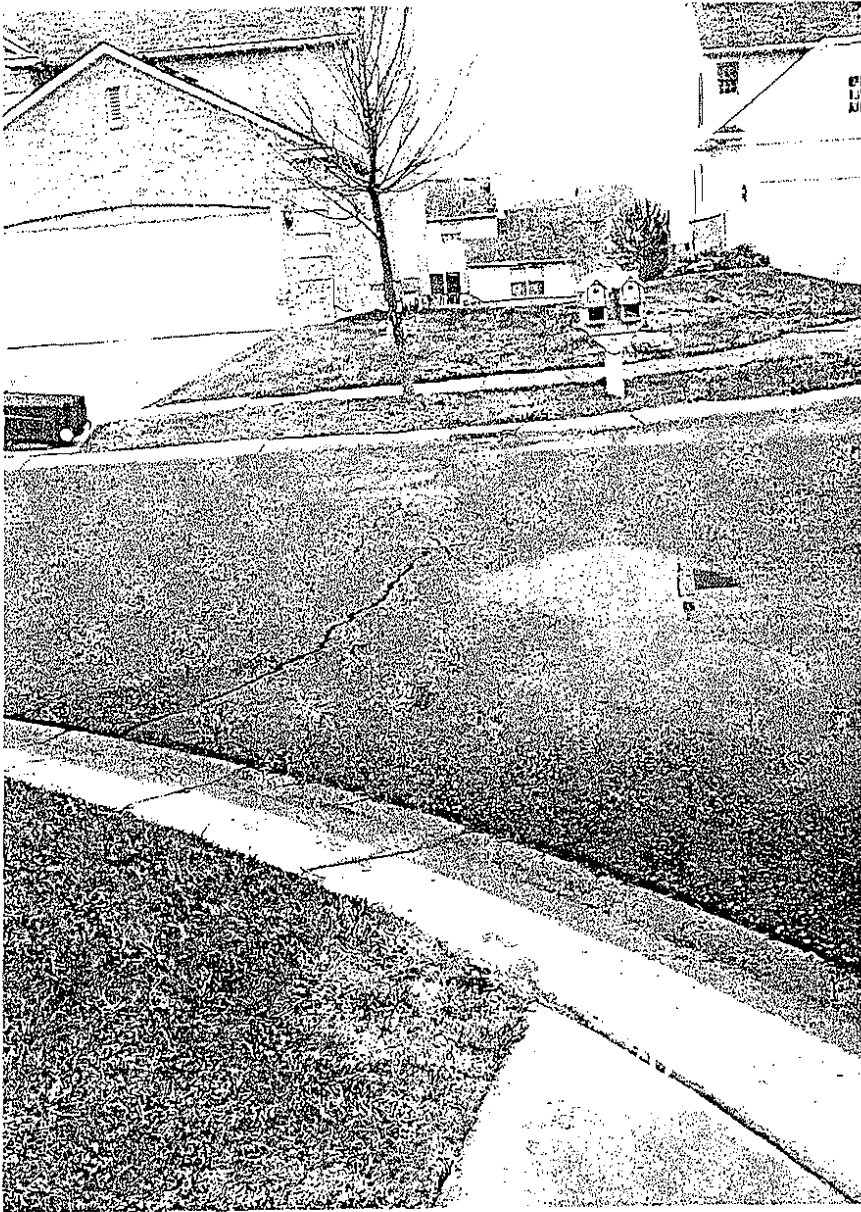
Sandstone at Quarry Ct.

Cracking, heaving and ponding
on top of storm sewer line.

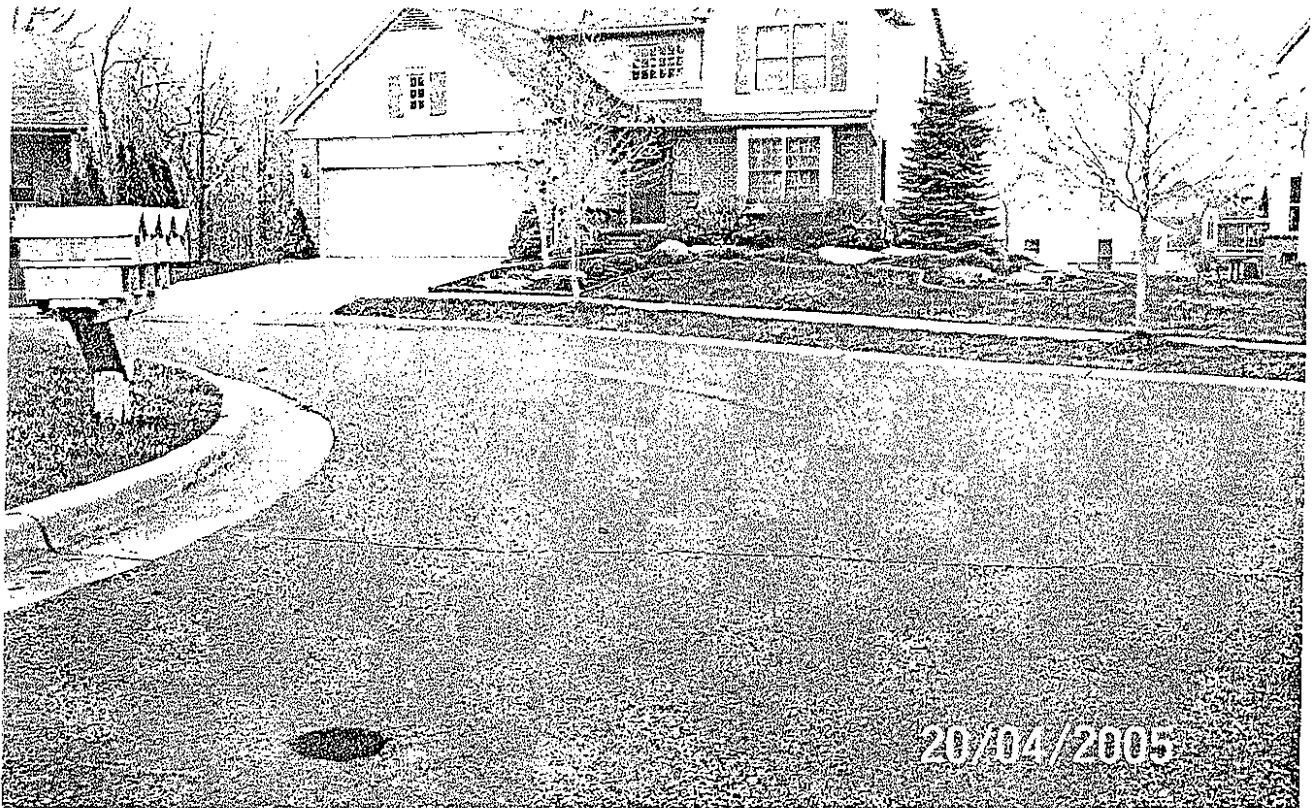
Quarry Ct. at north side of cul-de-sac island
Londitudinal and transverse cracking.

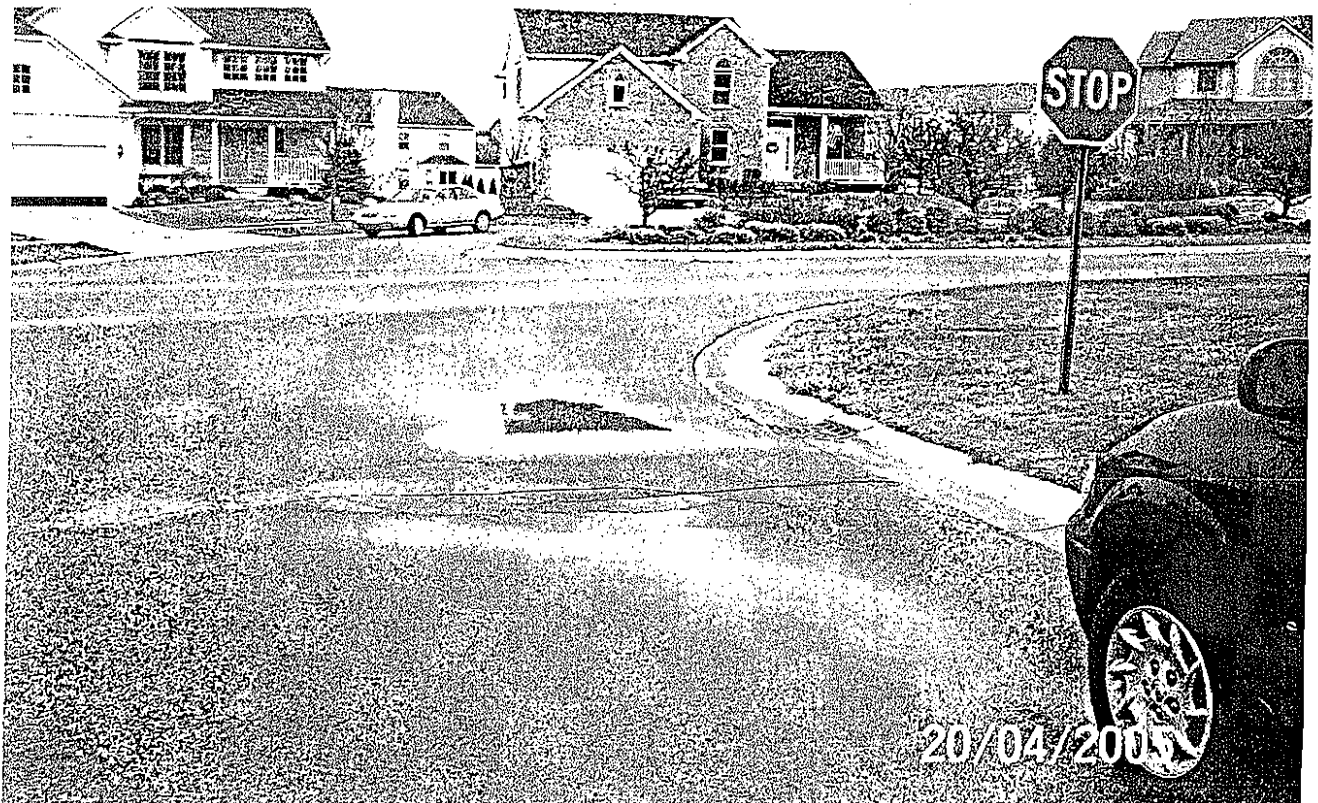
Quarry Ct. at Sandstone
Ponding and cracking in front of catch basin.

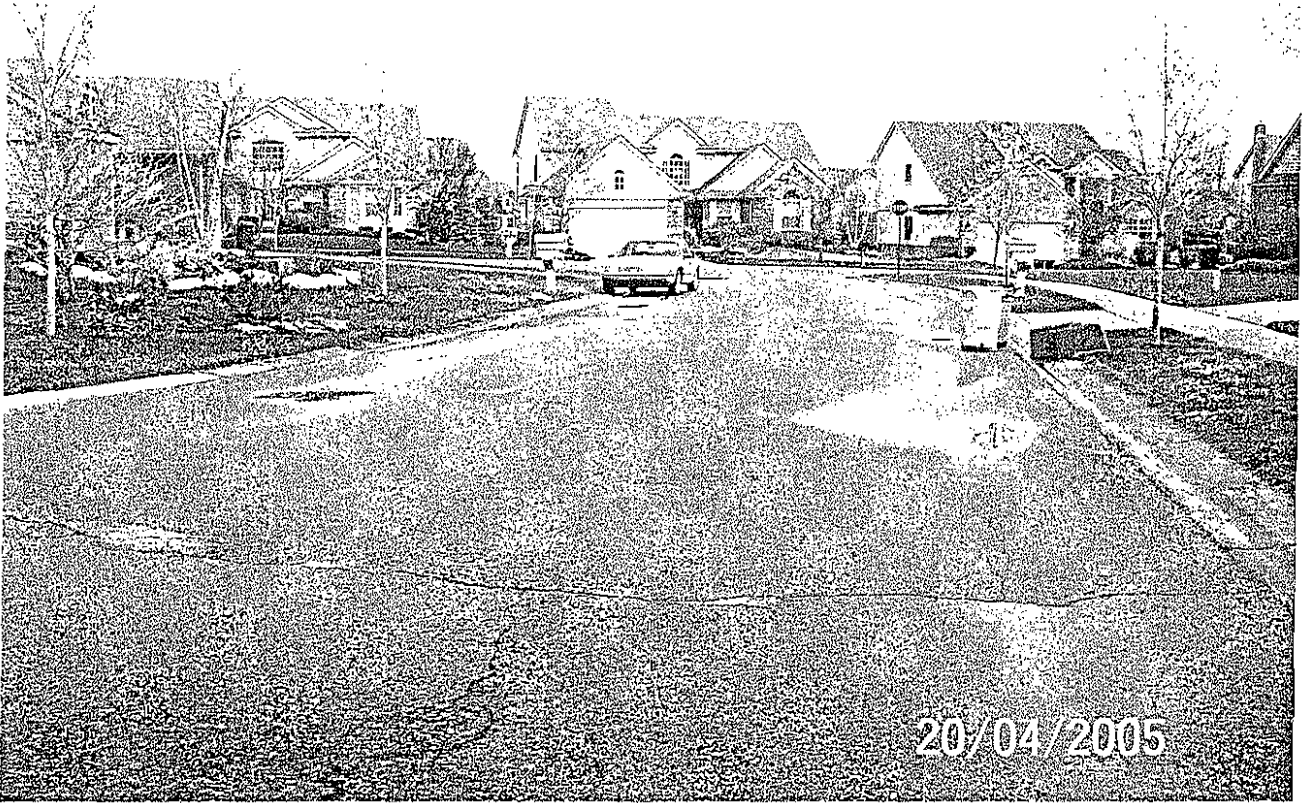
Stonewall Ct. at cul-de-sac island, looking toward Sandstone
Cracking and multiple areas of surface ponding.

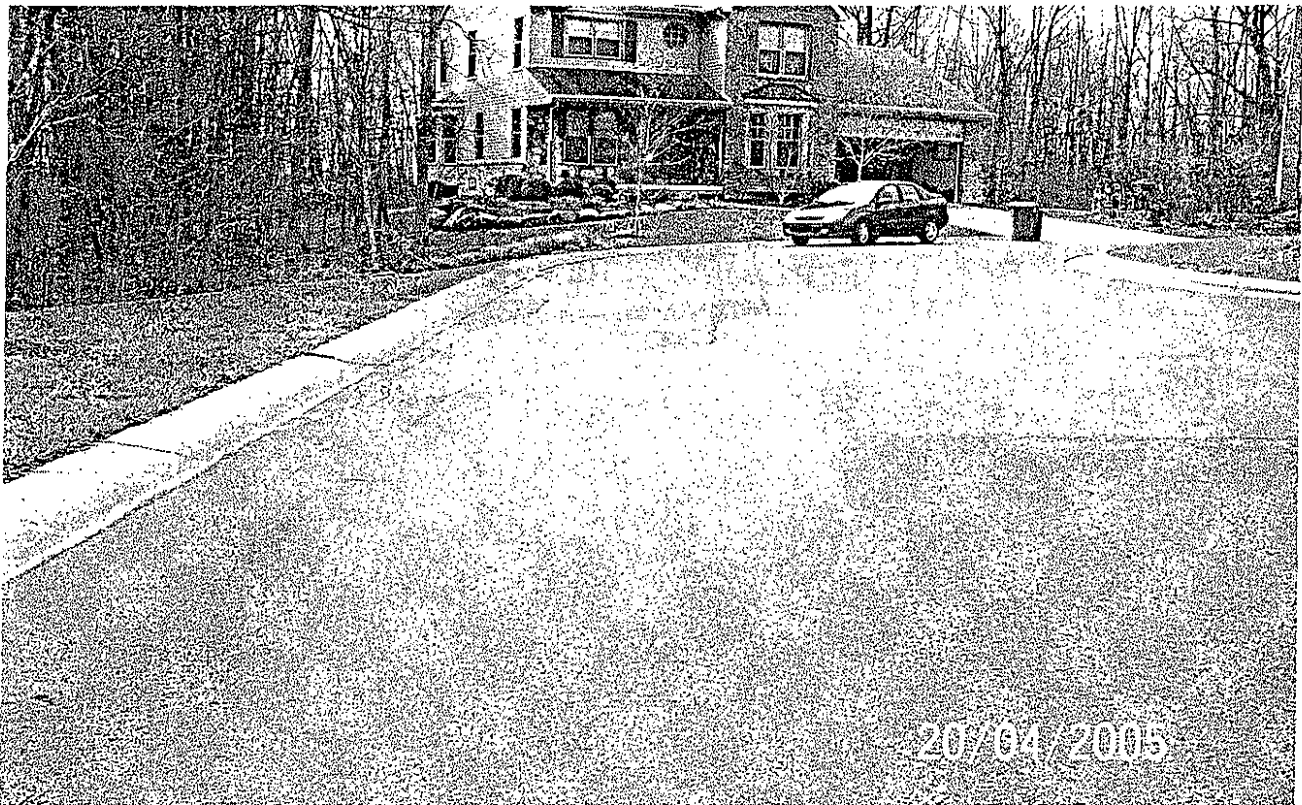
Stonewall Ct.
Variety of surface cracking.

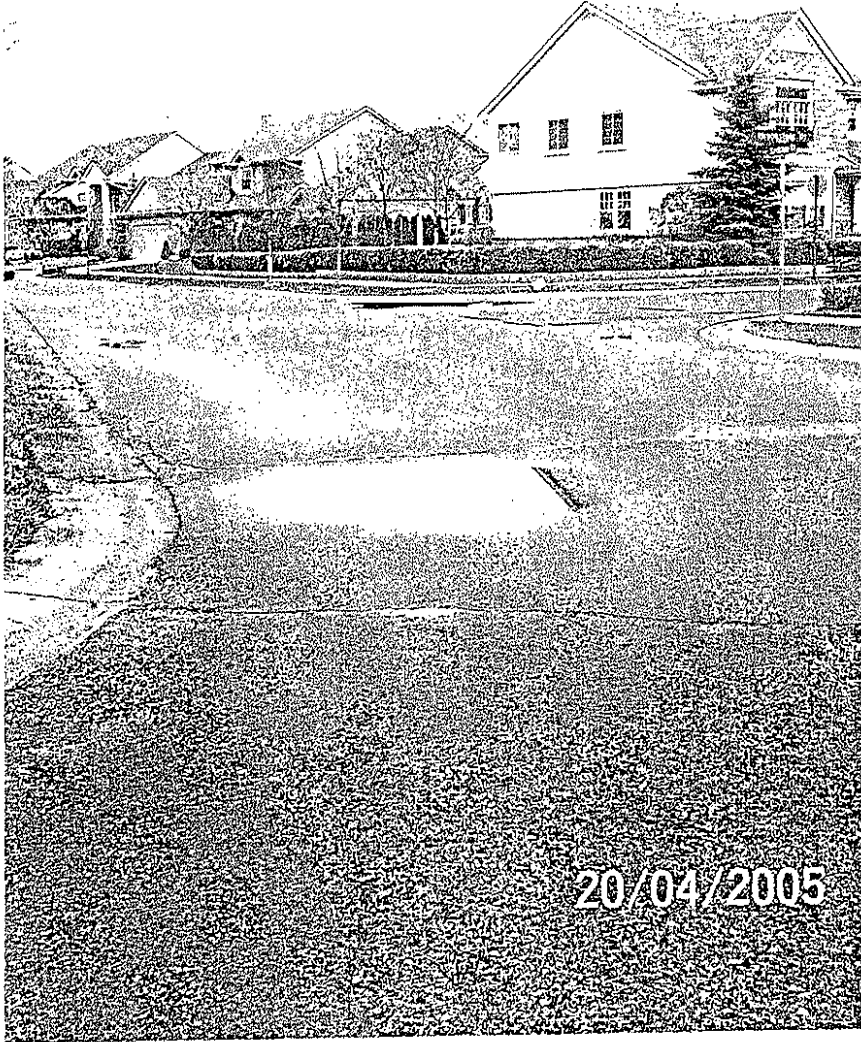
Sandstone near Brookstone
Multiple low points in pavement
with surface ponding and cracking.

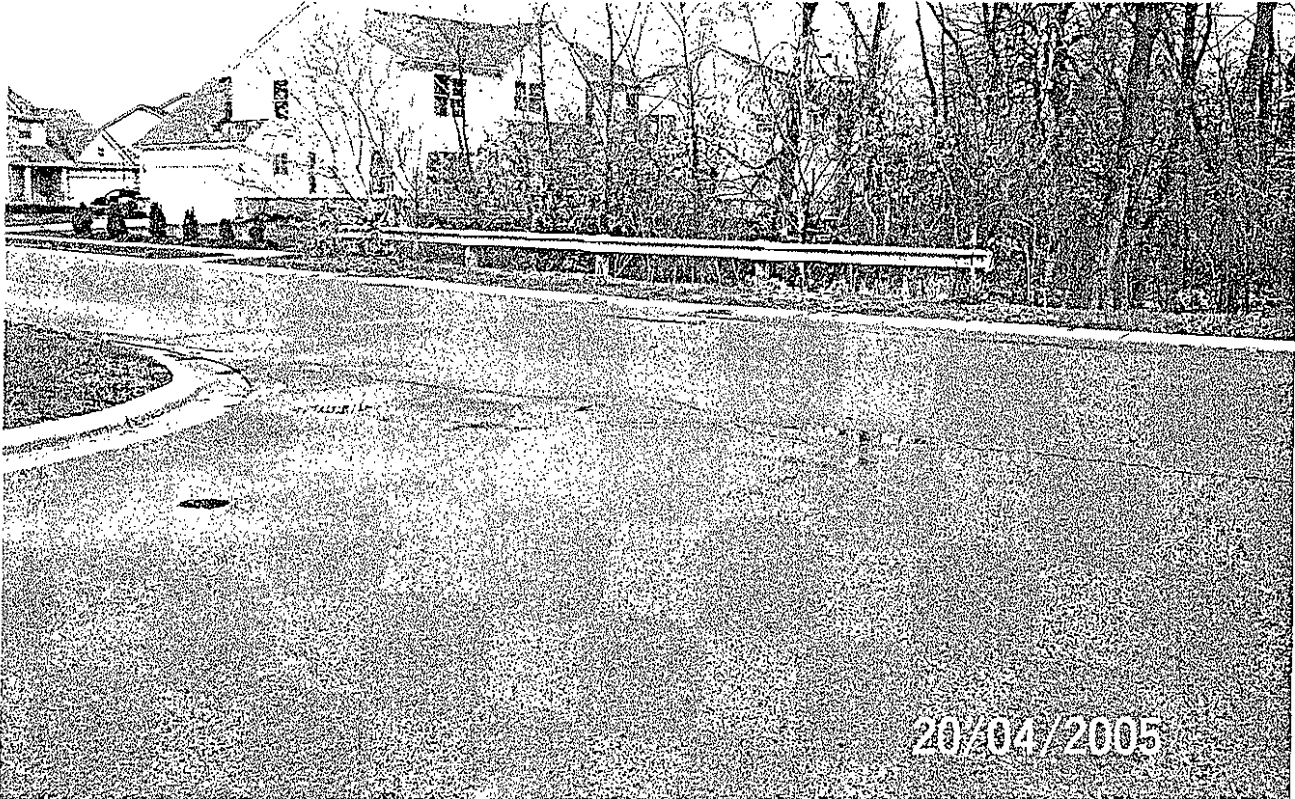
End of Sandstone at eyebrow cul-de-sac
Low point on pavement with ponding upstream of catch basin. The crack runs across the length of the intersection.

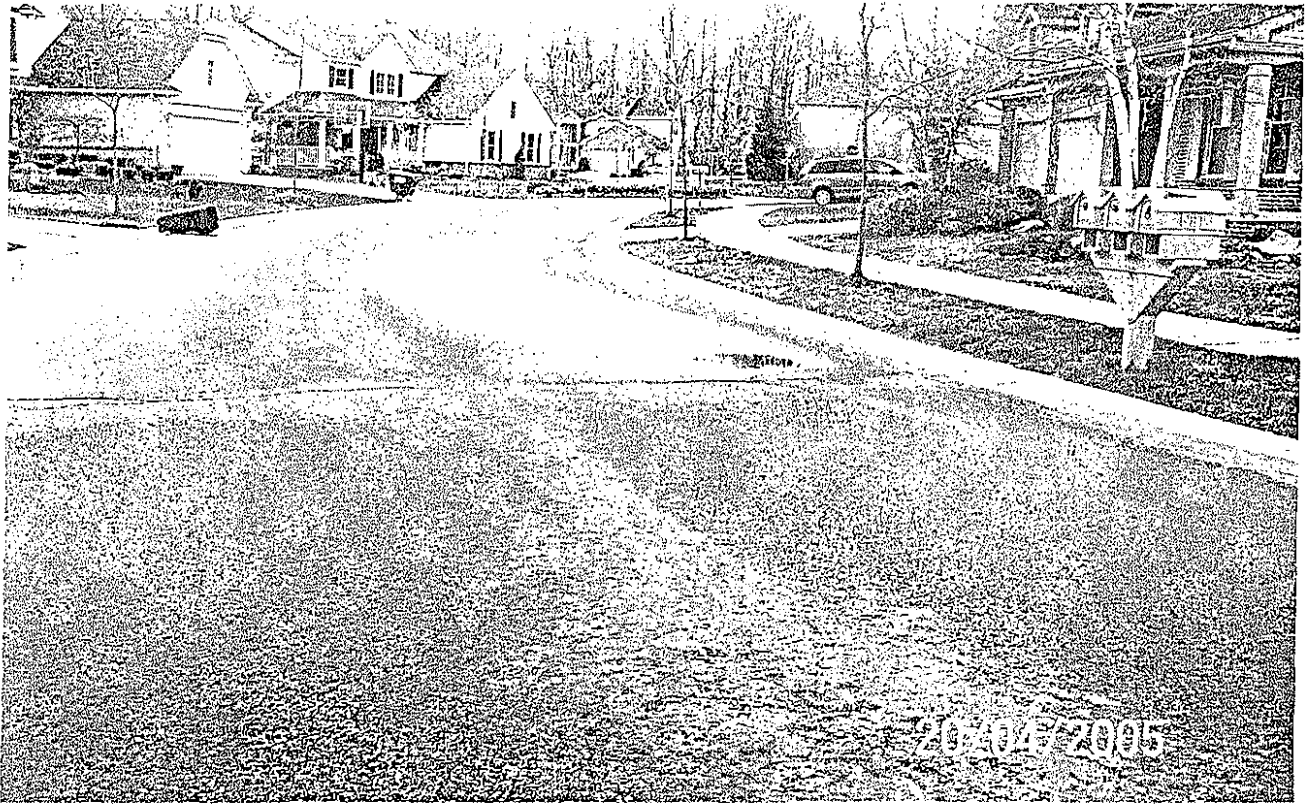
Brookstone between house no. 42769 and house no. 42797
Low point in pavement surface and transverse crack.

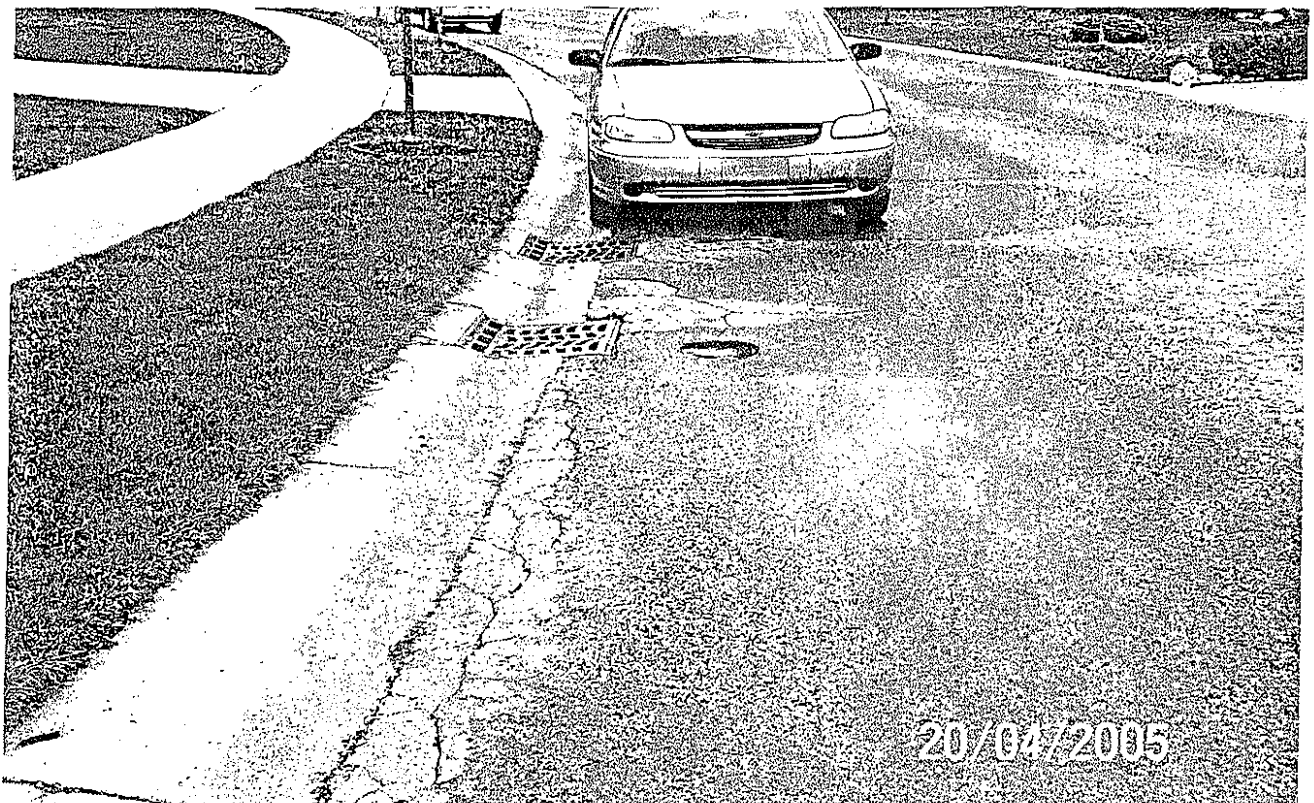
Brookstone at house no. 42813
Minor ponding in front of catch basins and cracks at edge of metal.

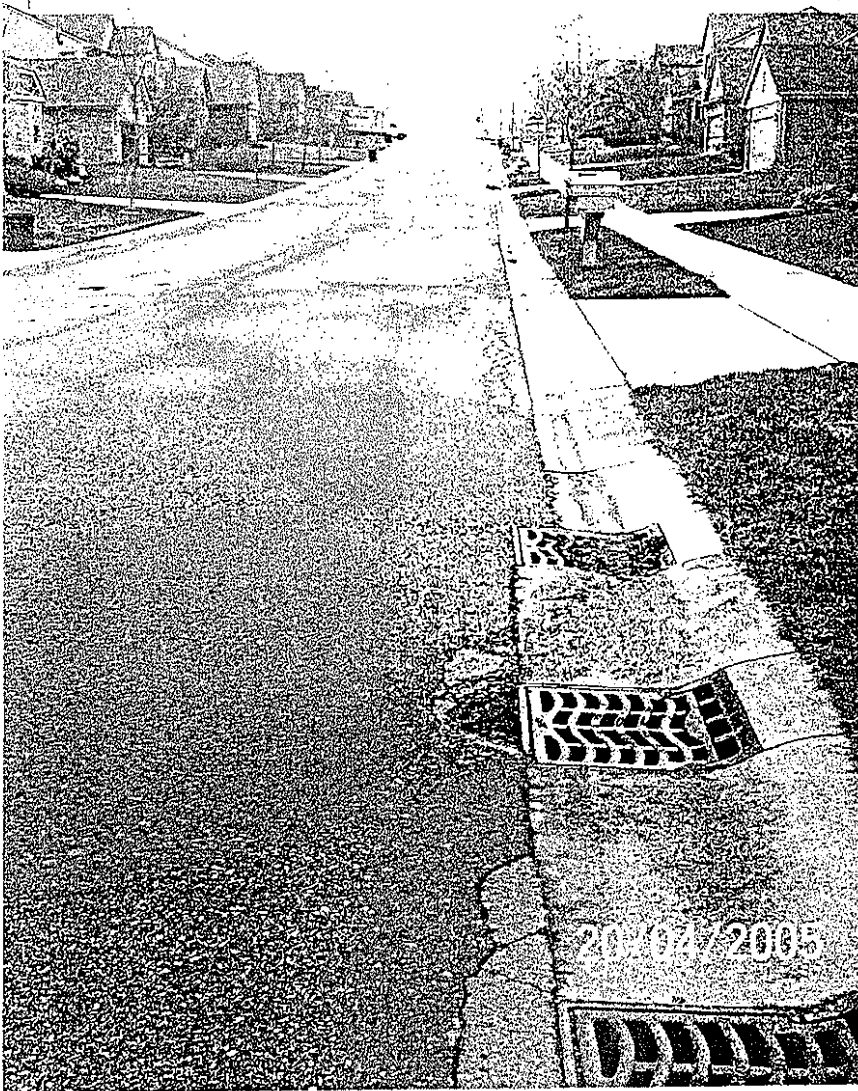
Hearthstone at house no. 42989
Ponding upstream of catch
basins. Edge cracking is evident.
A pot-hole has formed in front
of the middle catch basin.

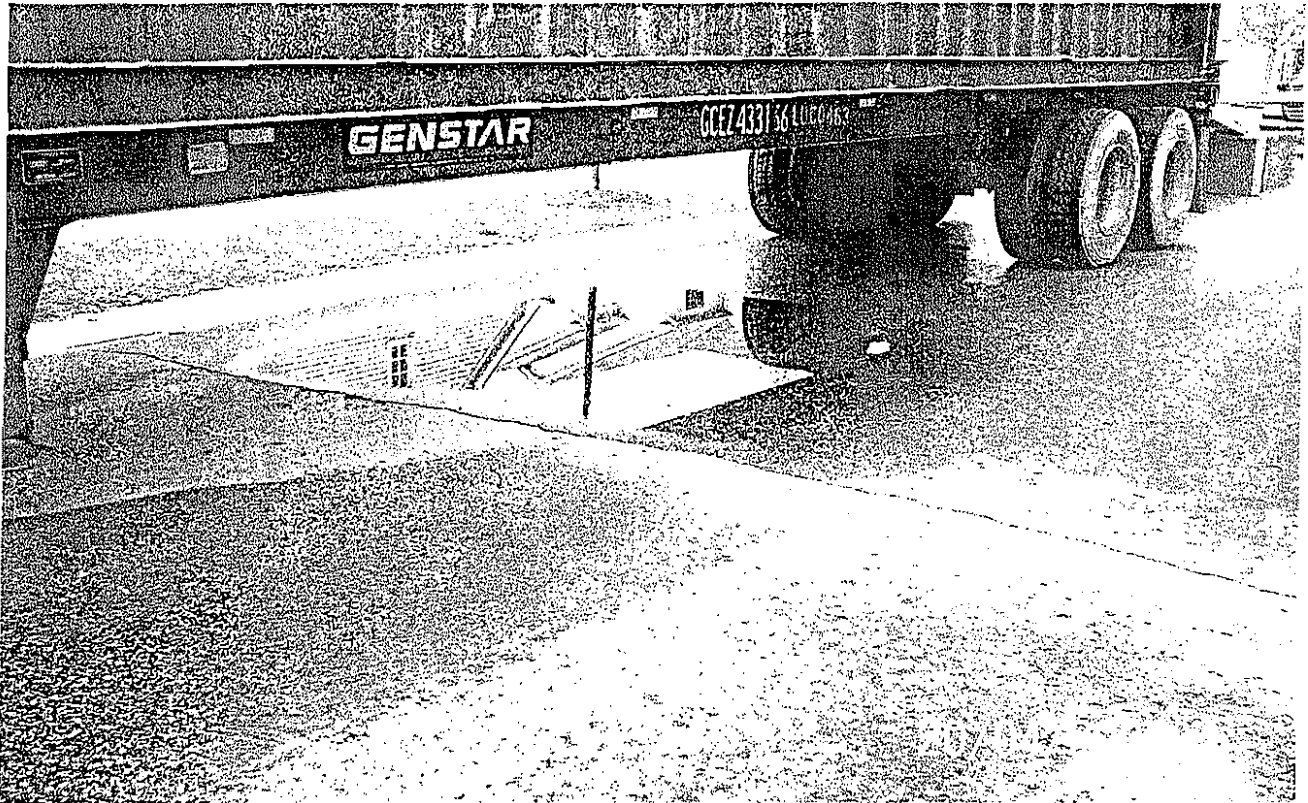
Brookstone at house no. 42989
Large area of ponding on south side of road with transverse crack.

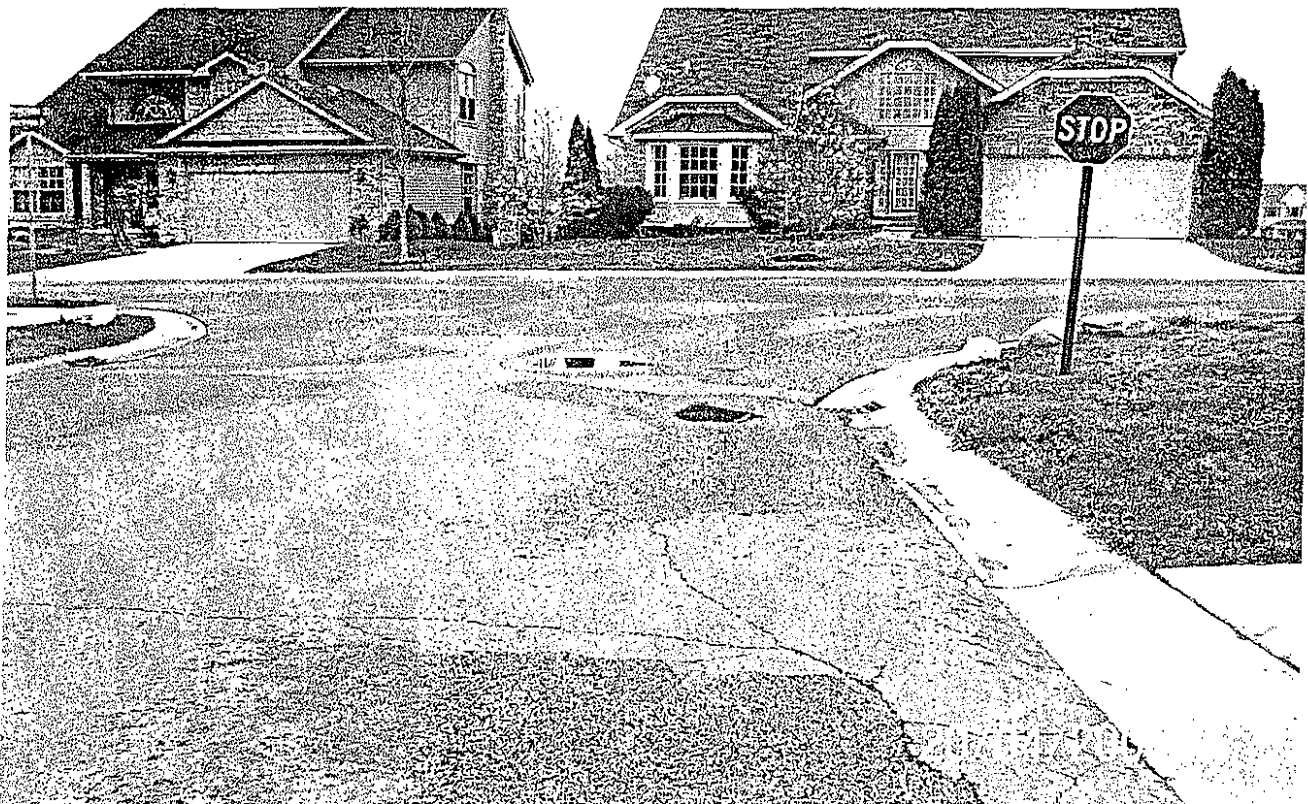
Brookstone at Hearthstone
Low point and ponding in front of catch basin with transverse cracking.

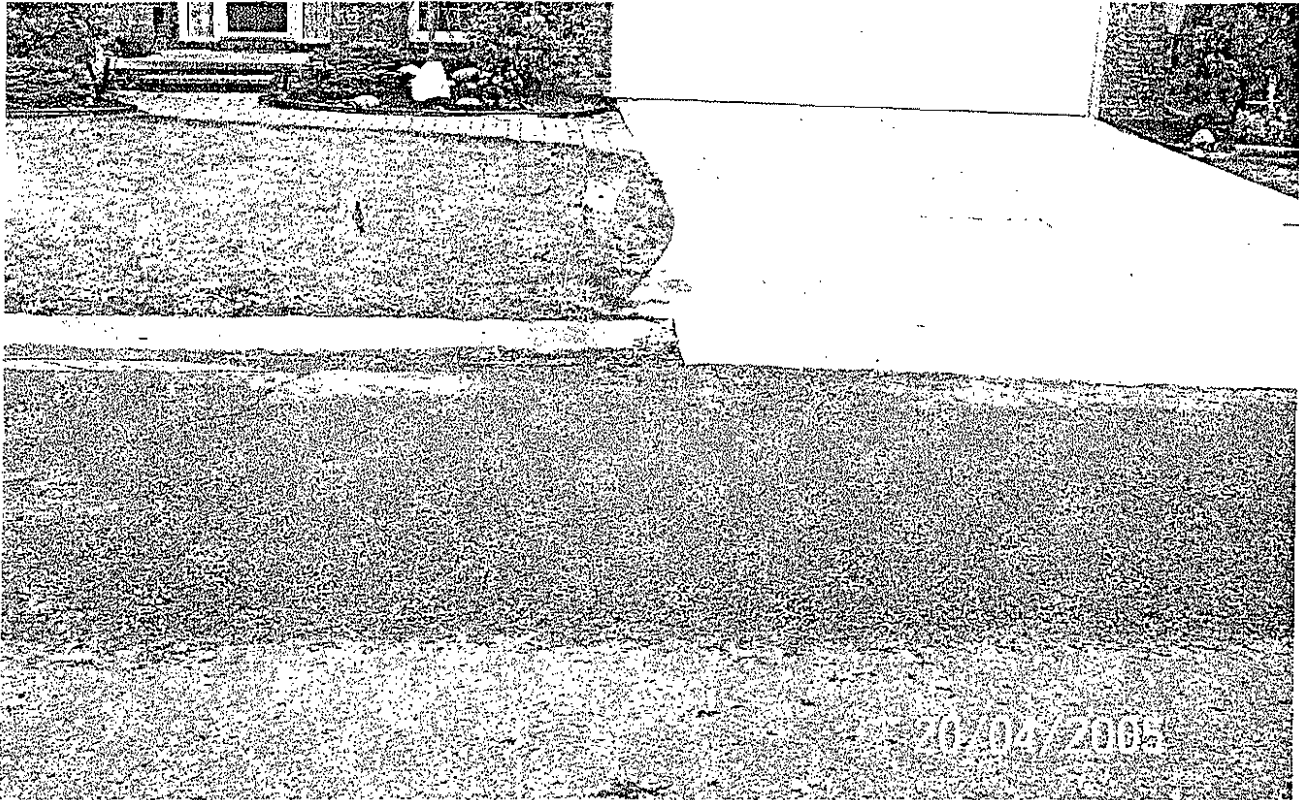
Hearthstone at house no. 28779

Dislocation of curb and gutter have caused a lip between the two sections, sediment has accumulated and the edge is showing signs of cracking.

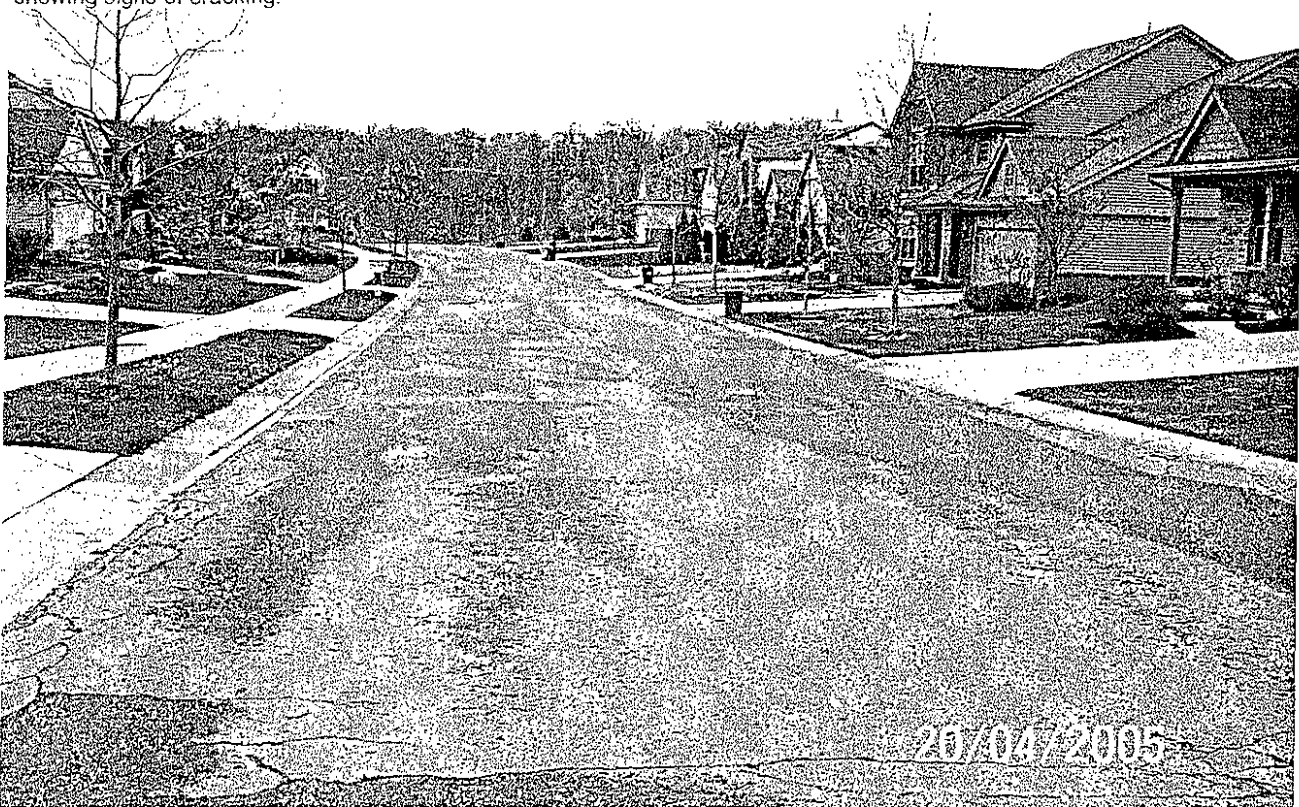
Hearthstone at house no. 28807, looking toward Sandstone

Longitudinal cracking, transverse cracking and cracks at edge of metal.
