SUBJECT: Consideration of a request from the Vista Hills Homeowners Association for the City to accept Vista Hills streets contingent on City's receipt of Association's \$190,000 payment for the City to make required pavement and storm structure repairs.

Vista Hills Subdivision Pavement and Drainage Structure Evaluation

VISTA HILLS SUBDIVISION
PAVEMENT AND DRAINAGE STRUCTURE EVALUATION
PREPARED FOR THE
CITY OF NOVI

May, 2005
Project No. 230799.00.000

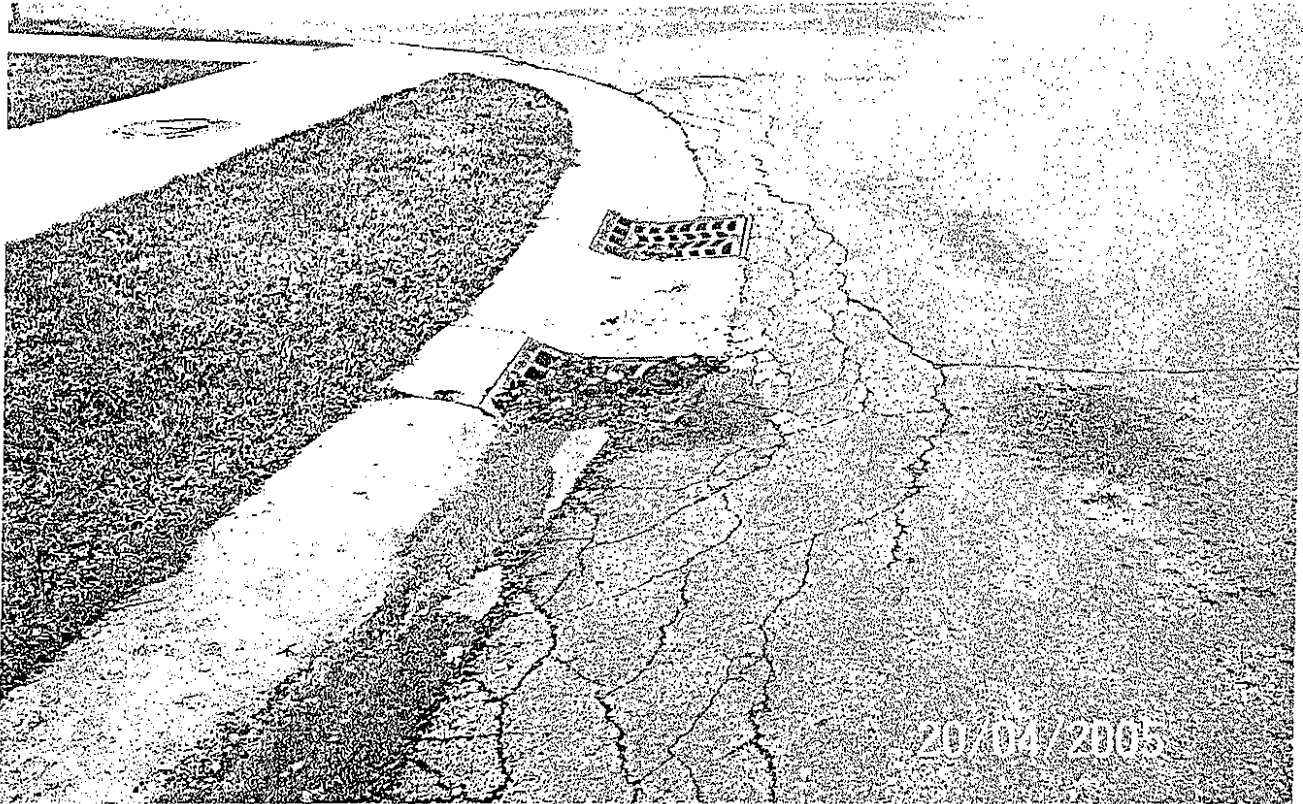
Ledgeview at Hearthstone
Pot-hole has formed in front of catch basin and edge cracking. The cracking continues into cul-de-sac on both sides of roadway.

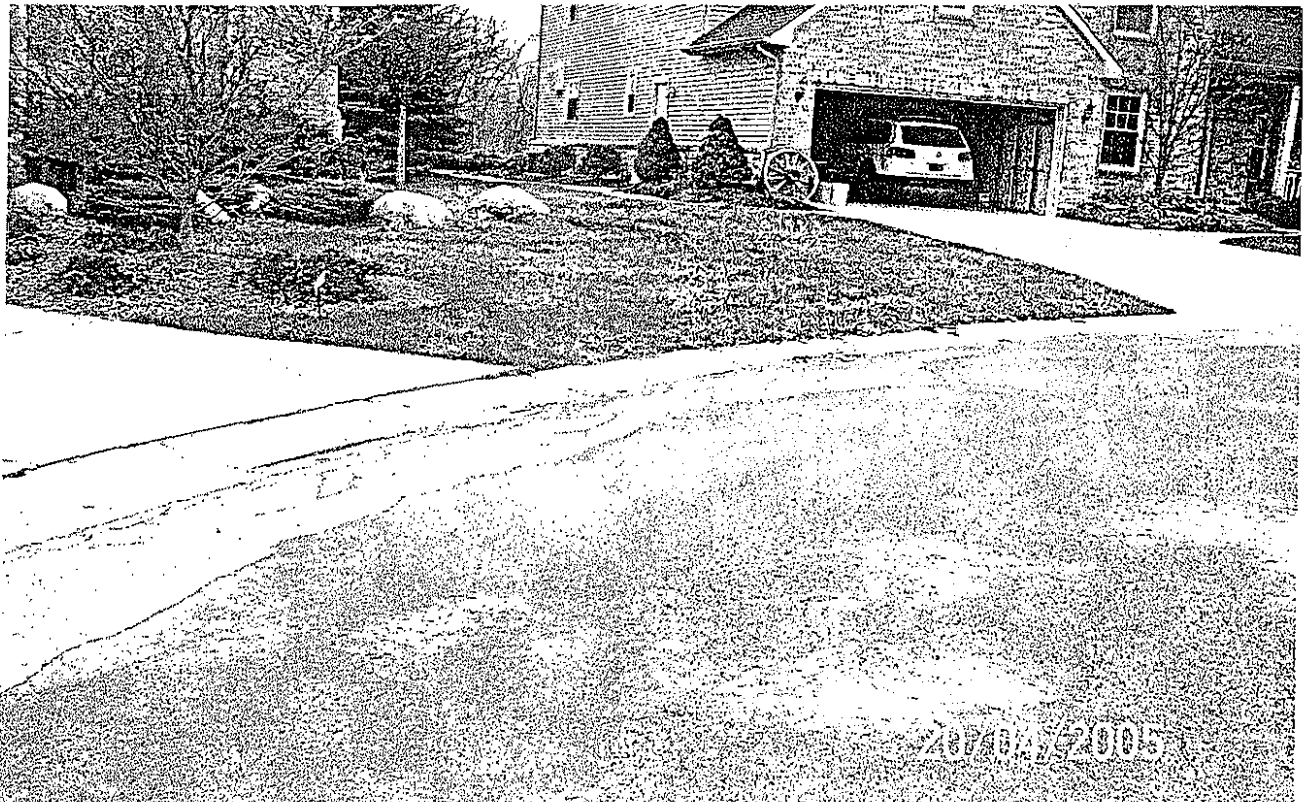
Ledgeview at house no. 42768
Apparent low point in curbing with sediment buildup and edge cracking.

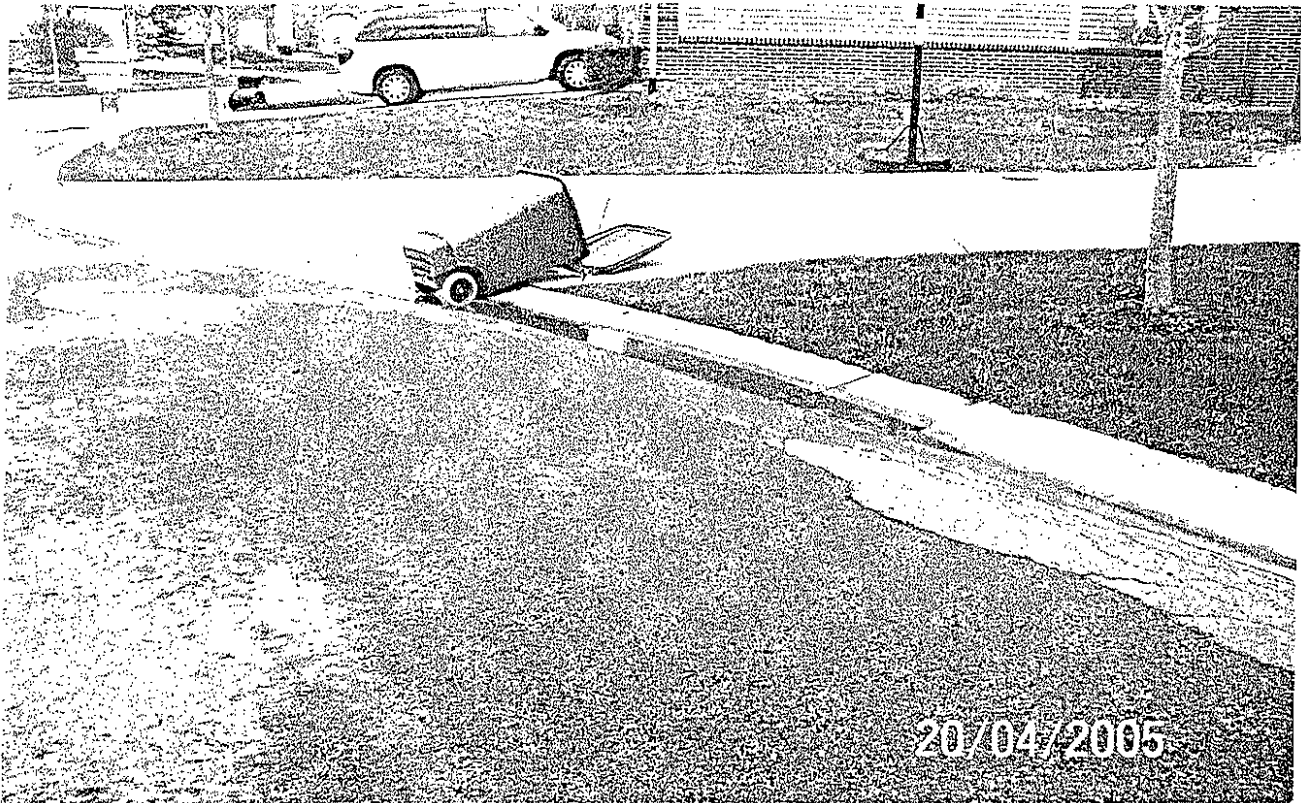
Ledgeview at house no. 42790
Pronounced low point in curb with ponding and edge cracking.

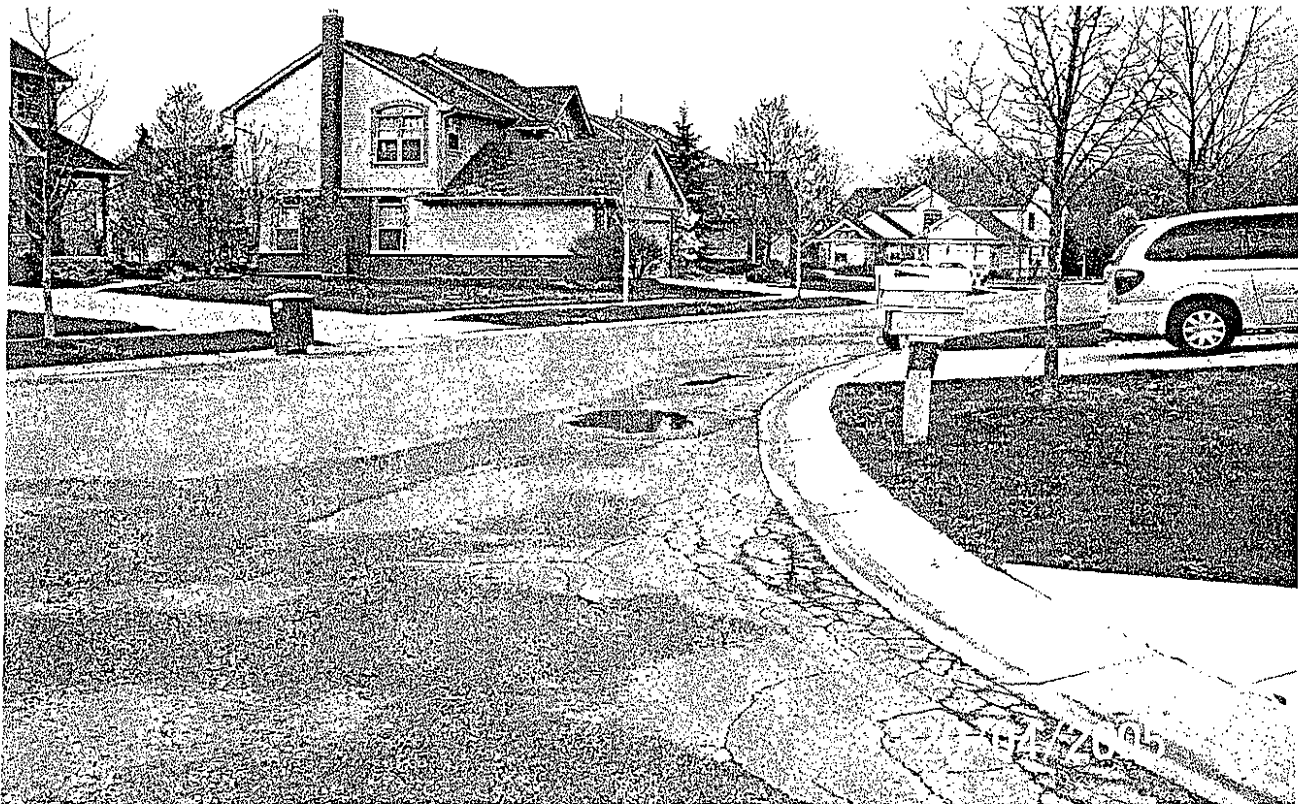
Ledgeview on north side of road at cul-de-sac curb return
Low points in pavement surface with ponding and edge cracking.

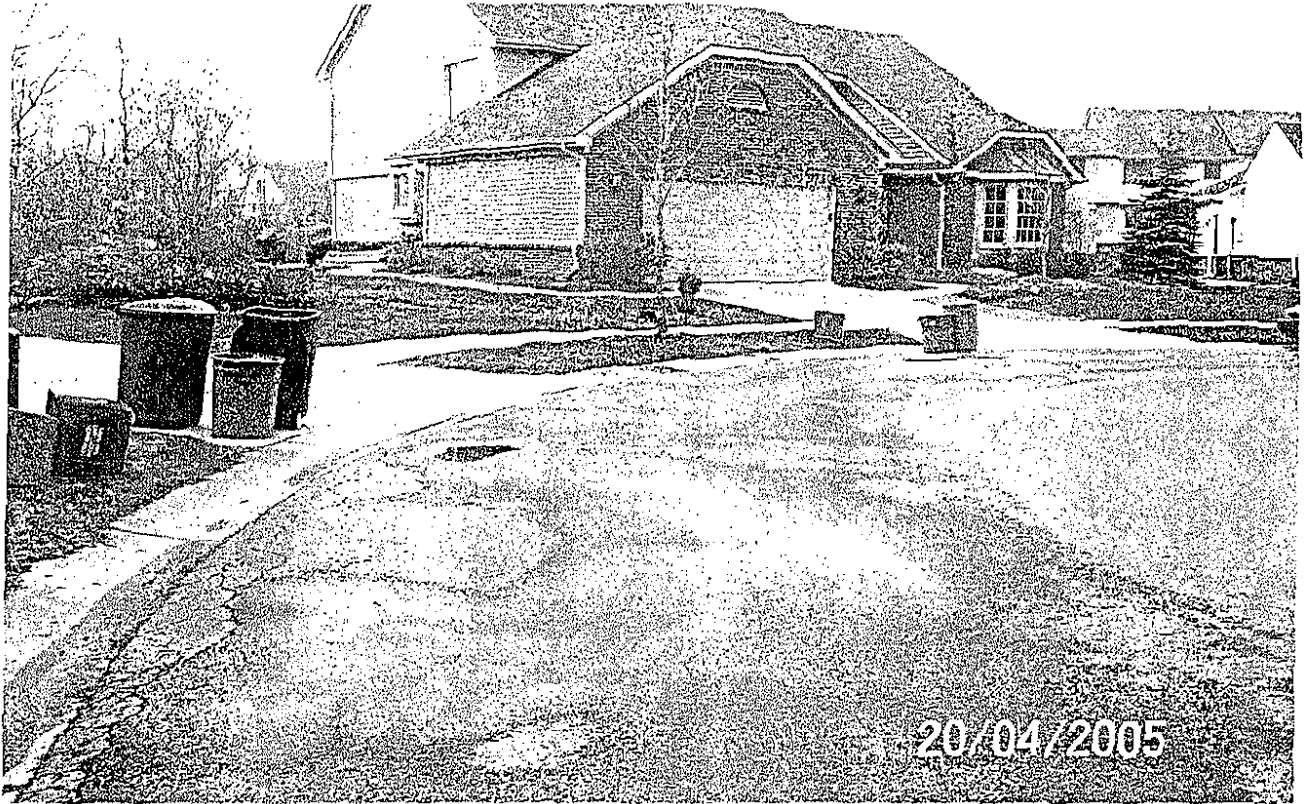
Ledgeview at house no. 42745
Ponding near edge of metal and edge cracking.
