# CITY of NOVI CITY COUNCIL

**SUBJECT:** Adoption of a Resolution seeking participation in the Michigan Department of Transportation (MDOT) Local Bridge Program for a grant application for the rehabilitation of the Cranbrooke Drive Bridge over Ingersol Creek.

## 2010 Local Bridge Program Application

Re: 2008 Bi-Annual Bridge Inspections-  
Cranbrooke Drive over Courter Ditch

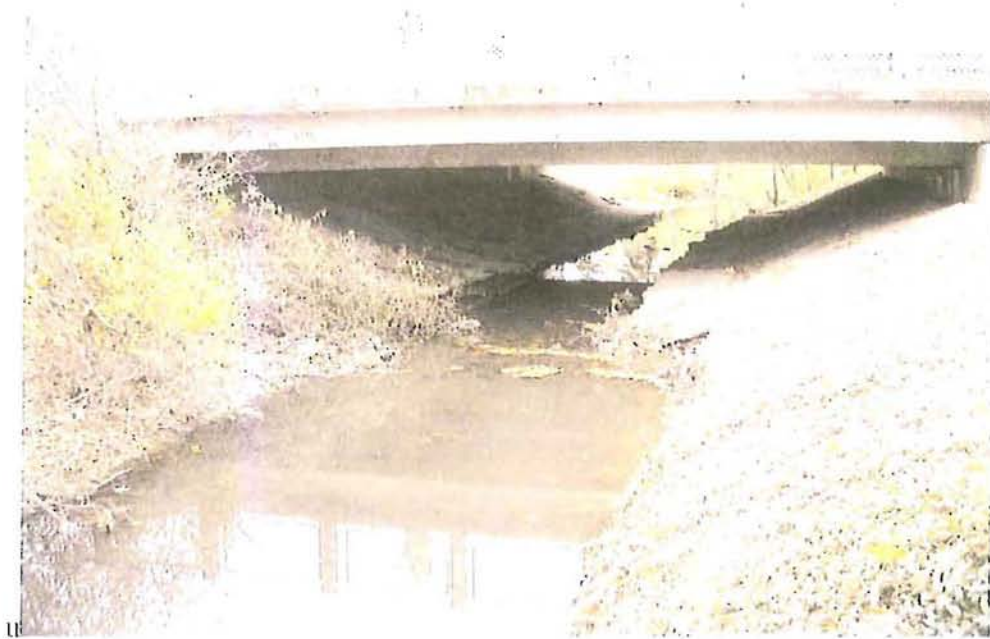
Cranbrooke Drive over Courter Ditch – East Fascia shown

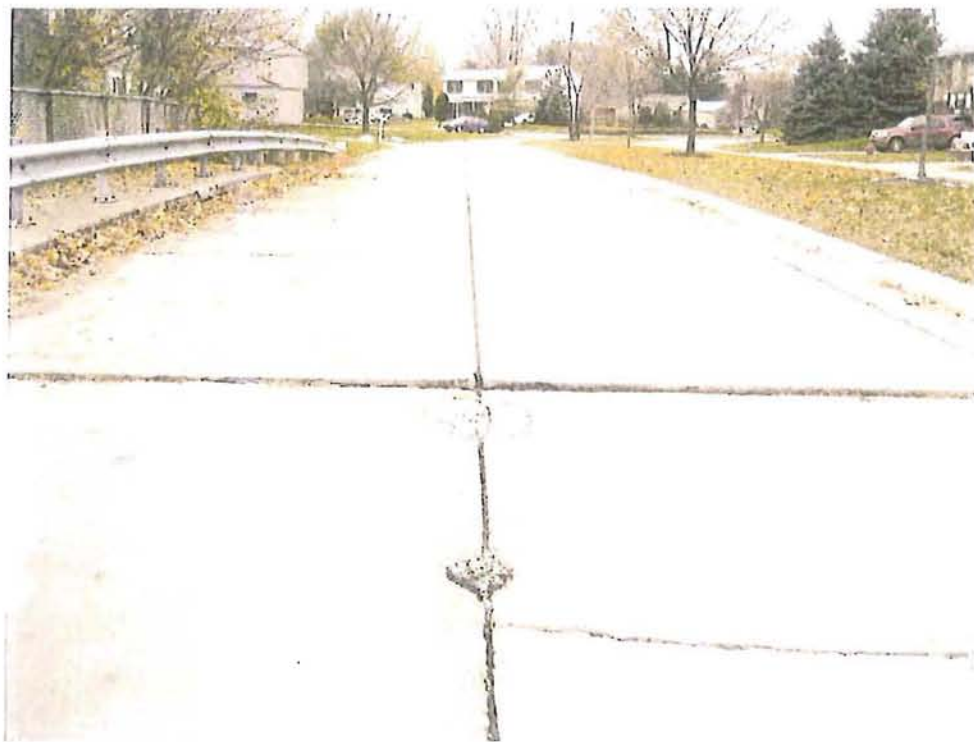
| 1. Surface SIA-58A | 8 | 8 | 7 | Several transverse cracks in concrete surface in northbound lanes. Bituminous patch at longitudinal joint in southbound lanes. Landscaping across bridge in median. ( 08)<br>Concrete pavement is in good condition. ( 06)<br>( 04) |

Typical condition of deck surface – Northbound lanes shown

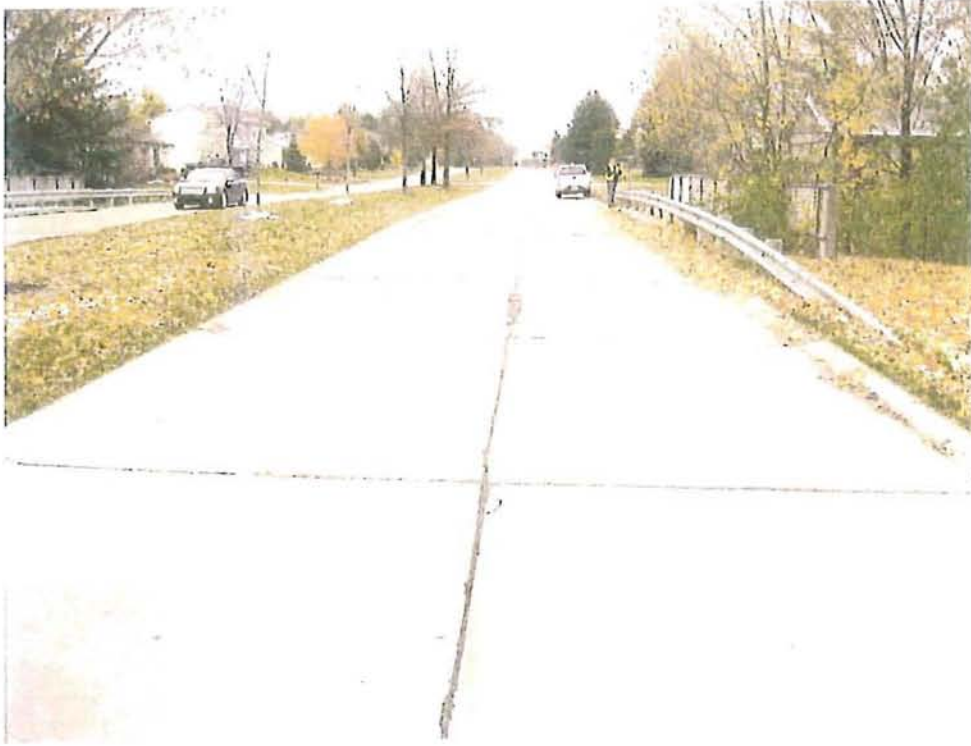
16. Approach Pavt 7 6 6 The approach pavement has settled 1/2" +/- in all quadrants. The concrete approach pavement has a few small areas of bituminous patching at the longitudinal joints. Few transverse cracks observed in the northbound lanes. (08)  
Has settled 1/2" +/- in all quadrants. (06)  
(04)

Typical Approach Pavement Condition

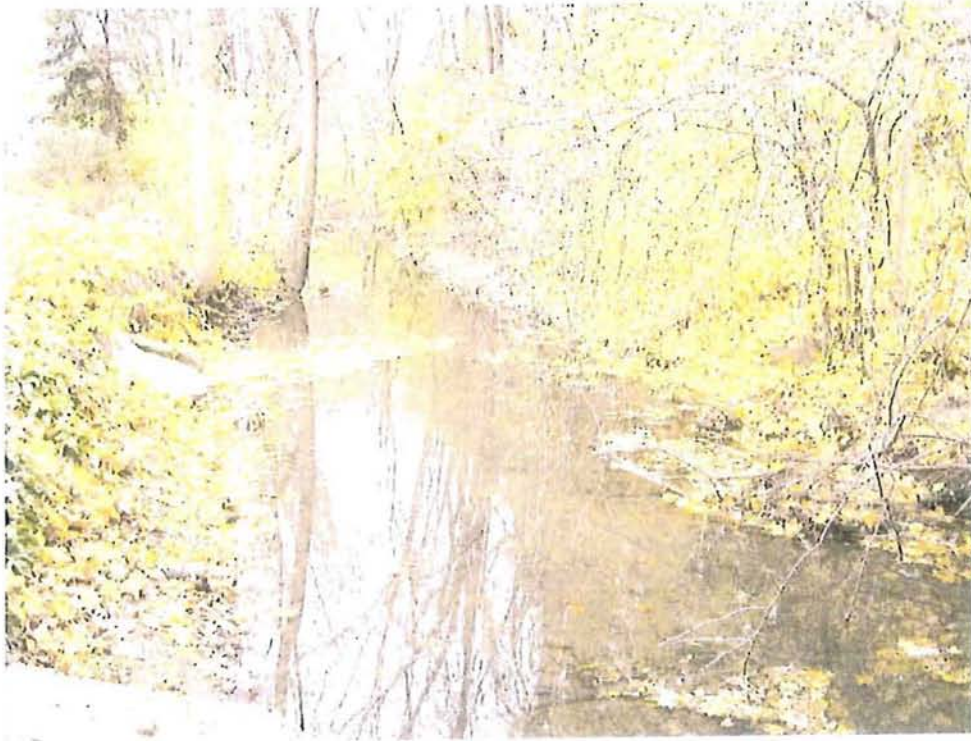
Courter Ditch – Looking Downstream from structure

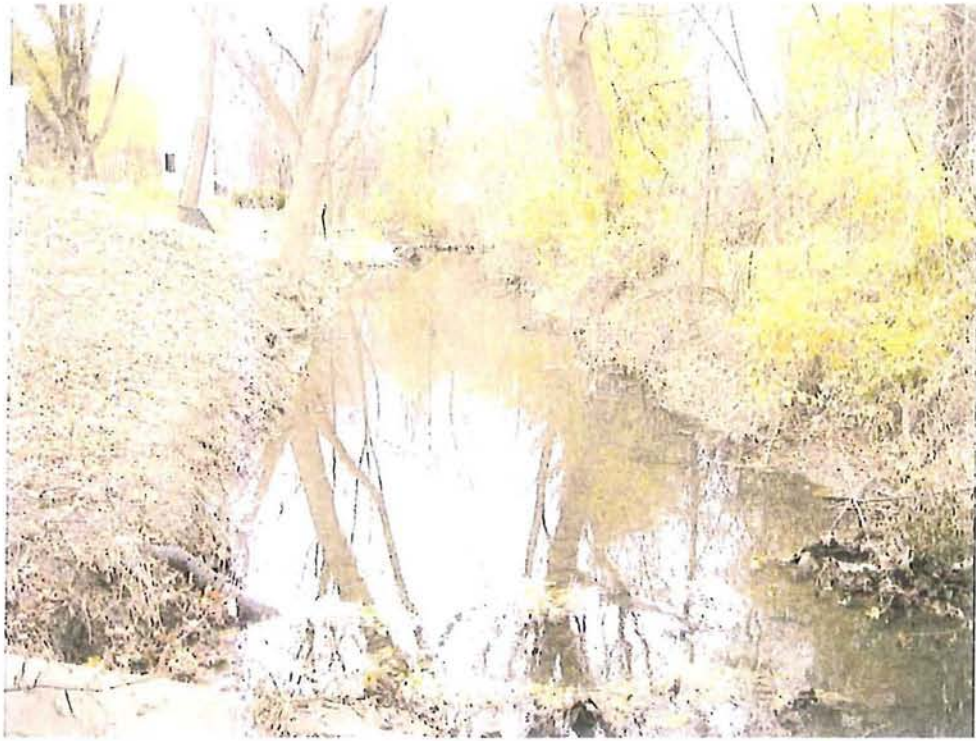
Courter Ditch – Looking Upstream from structure

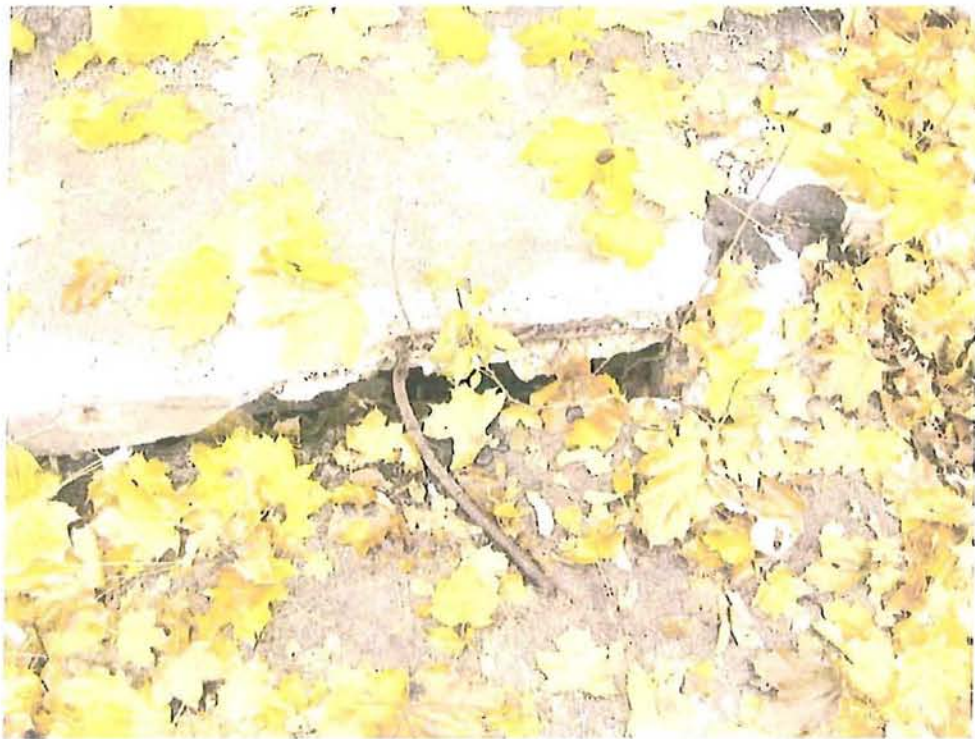
| 5. Sidewalks or curbs | 7 | 7 | 6 | The west sidewalk along the curb line is spalled and the rebar is visible. Ends of the rebar are visible along the curb line of the east sidewalk. ( 08)<br>The west sidewalk along the curb line is spalled and the rebar is visible. Ends of the rebar are visible along the curb line of the east sidewalk. ( 06)<br>( 04) |

Toe of west sidewalk – spalled concrete, expose and corroded reinforcing steel.

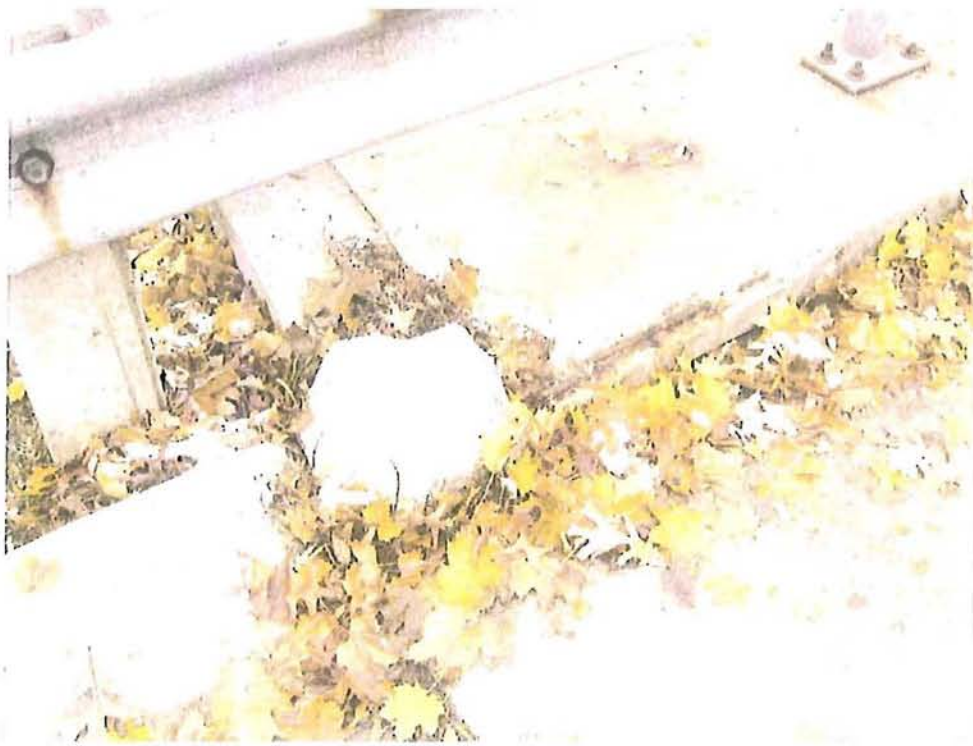
Toe of west sidewalk and top of abutment wall – spalled concrete with exposed reinforcement.

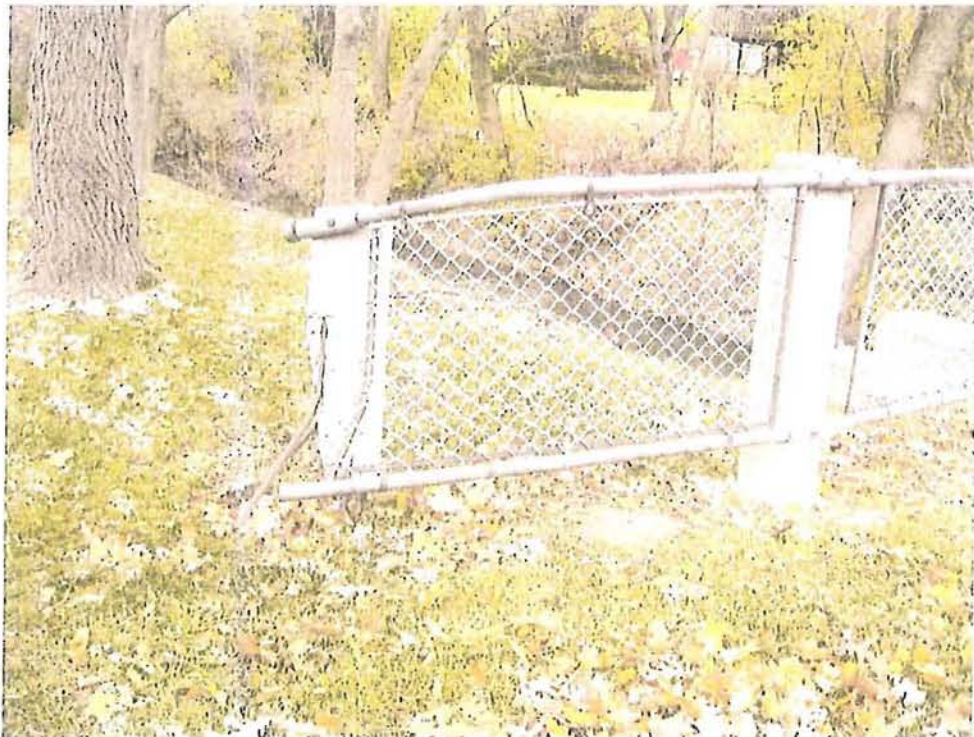
| 4. Railings | 6 | 6 | 5 | Concrete posts steel rails/pedestrian fencing. The last post of the pedestrian railing is damaged, with spalled concrete and exposed/bent reinforcing bars, in the NE quad. Posts and fence on bridge are in fair condition - no spalls to concrete or section loss in railing observed. ( 08)<br>The last post of the pedestrian railing is damaged in the NE quadrant. Fence and post on bridge are in good condition. ( 06)<br>( 04) |

Damaged concrete post in the northeast quadrant of the bridge.

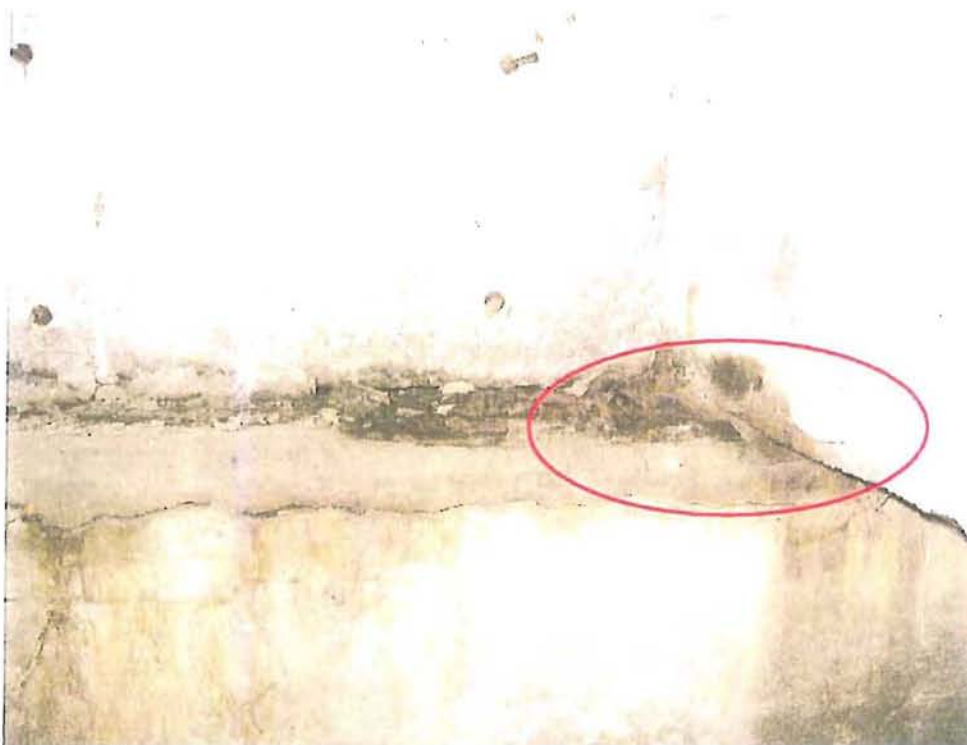
11. Section Loss (08)  
(06)  
(04)
12. Bearings 6 6 4 All steel plates are heavily corroded with some pack rust present. The elastomer is bulging and cracked. The sole plates cast into the beams are also heavily corroded, some with extensive pack rust. Anchor bolts are heavily corroded. (08)  
The elastomer is bulging and cracked. Steel plates are corroded. (06)  
bearing plates where the box beams rest are rusting and flaking off (04)

Typical condition of bearings. Bearings have heavy pack rust and section loss. Concrete at bottom of beam at bearings is cracked.

- Repair all delaminated/spalled concrete at each abutment
- Replace the bearings
- Repair the beam ends
- Repair the existing slope protection and place additional riprap below the bridge to prevent further scour.

One option for repairing the beam ends and bearings is to fully encase the beam ends in concrete.

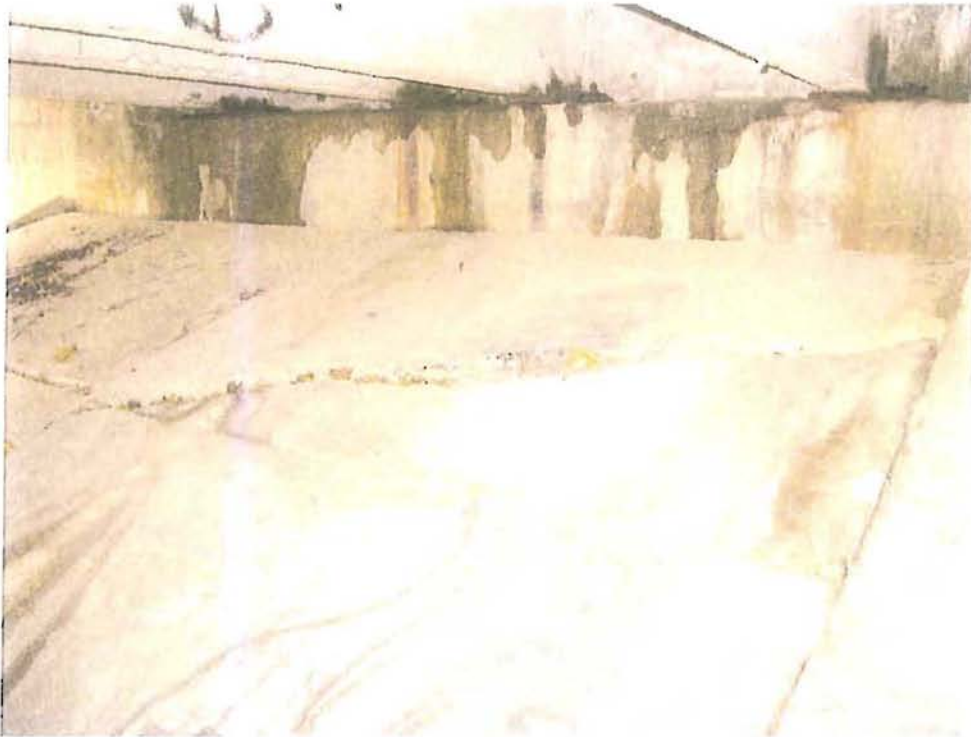
13. Abutments SIA-60 7 6 4 North abutment seat spalled and delaminated at beams 4E thru 8E and 4W thru 6W. The spalled/delaminated areas extend under the bearings (5-10% of bearing area). The abutment walls are rust stained and efflorescence is present along the entire length of both abutments. 2' x 8" spall at the top of the south abutment. Rebar visible at several of the spalled areas. (08)  
Vertical cracks at the road drainage opening locations in all four quadrants. 2' x 6" spall at the top of the south abutment. Several horizontal leaching cracks 2'-3' long at the top of the abutment. Rebar visible in a few locations. (06)  
(04)

North Abut. Seat below beams 3W-6W wet. Beam seat is spalled between beams with exposed rebar. Spalls extend under bearing areas approx. 5%.

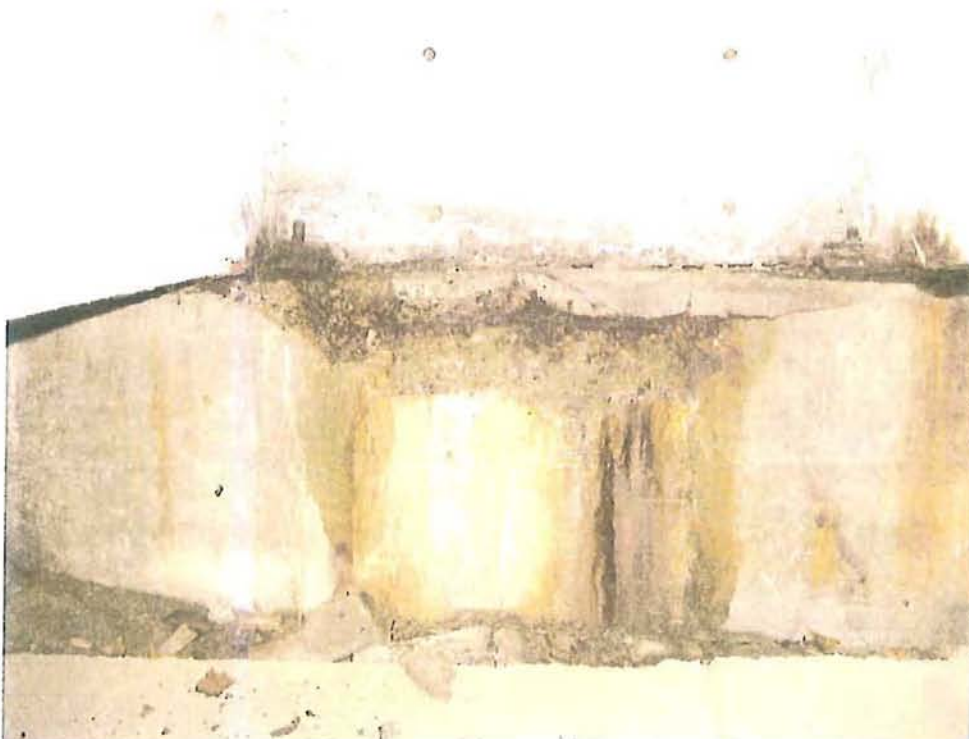
The abutment seat is delaminated and spalled at several locations along the north abutment. Evidence of heavy water leakage from the backwall is evident along the entire face of both abutments with rust staining and efflorescence present. The existing slope protection has been undermined by scour and has settled and cracked.

North Abut. Typical condition between beams 4E thru 8E. Abutment is wet, seat is spalled and rust stained.
