SUBJECT: Approval of Resolution adopting the Americans with Disabilities Act Compliance Transition Plan for public sidewalks and pathways.

**City of Novi, Oakland County, Michigan
ADA Compliance Transition Plan
City-owned Pathways and Associated Facilities**

February 2011

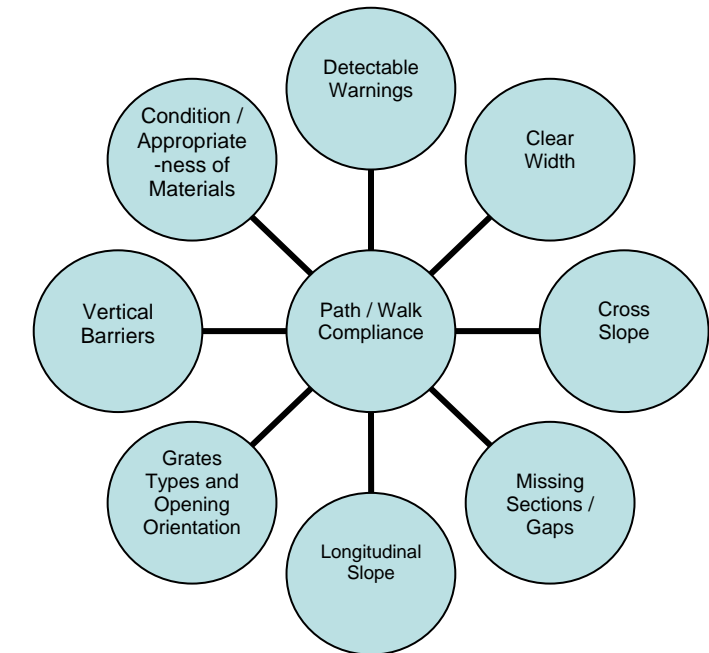
Figure 1: Pathway/Sidewalk Compliance Characteristics

In order to be compliant with the ADAAG, pathways and sidewalks must be of stable material, free of obstacles, and conform to particular size and slope requirements. The self evaluation therefore focused on these characteristics, as outlined in Figure 1 above.

- Presence of an obstacle within the walkway;
- Improperly installed driveways (residential and commercial) that interrupted the walkway;
- Damage or deterioration of the walkway resulting in an obstacle;
- Cross slopes exceeding 2%.

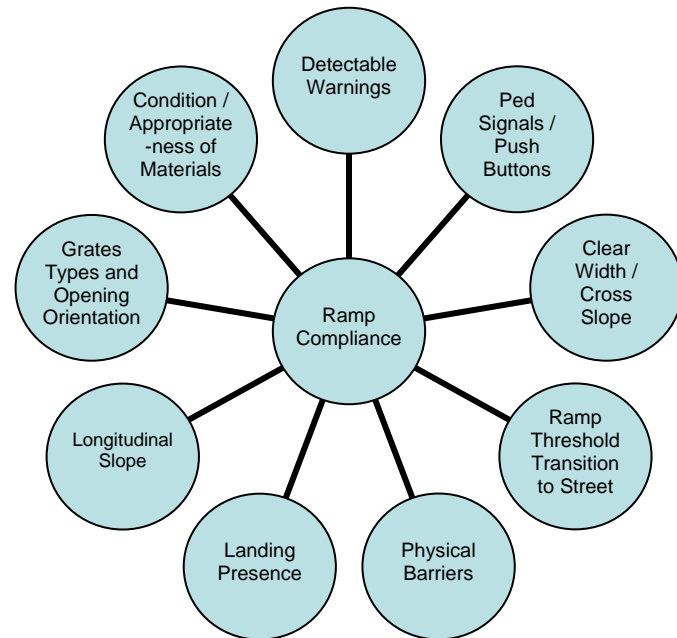
Figure 2: Curb Ramp Compliance Characteristics

The evaluation of intersections is more detailed, as numerous characteristics are reviewed. As noted in Figure 2 below, sidewalk ramps and landings must conform to geometric constraints (including size and slope), while also correctly

incorporating detectable warning measures and eliminating obstacles from the path.

- Lack of curb ramp and landing adjacent to existing pathway or sidewalk;
- Presence of an obstacle at the transition of the ramp and roadway curb;
- Damage or deterioration of the ramp and/or landing resulting in an obstacle;
- Lack of properly installed landing with slopes not exceeding 2% in any direction;
- Lack of properly installed ramps with slopes less than 1/12;

- Use of materials for ramp and landing construction that are susceptible to settlement, slipping, or are difficult to distinguish from detectable warning surfaces (i.e. asphalt, certain decorative pavers or stamped concrete);
- Lack of detectable warning devices (or installation of improper or significantly worn devices) at curb ramps;
- Improperly located pedestrian actuated signal buttons.
