## MEMORANDUM

**SUBJECT:** TIM POPE PLAY STRUCTURE SEALING

# ITC Community Sports Park Tim Pope Memorial Play Structure

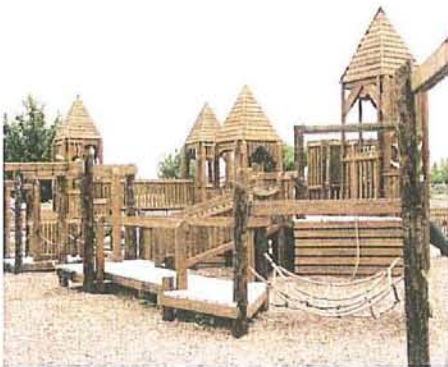
This year, the ITC Community Sports Park, Tim Pope Memorial Play Structure got a facelift. In June of 2009, the structure and perimeter fence was power washed, stained and sealed in an effort to maintain the structures beauty.

***Action: As decks and railings become worn from wearing against metal components, or are vandalized, staff replaces the custom parts with composite materials. It is suggested that the wooden portions of the structure are coated with sealer every 12 months. Power washing and application of a sealant was completed by Reasonable Improvements, LLC on June 26, 2009 in the amount of \$2,675. (Please reference attached photos).***

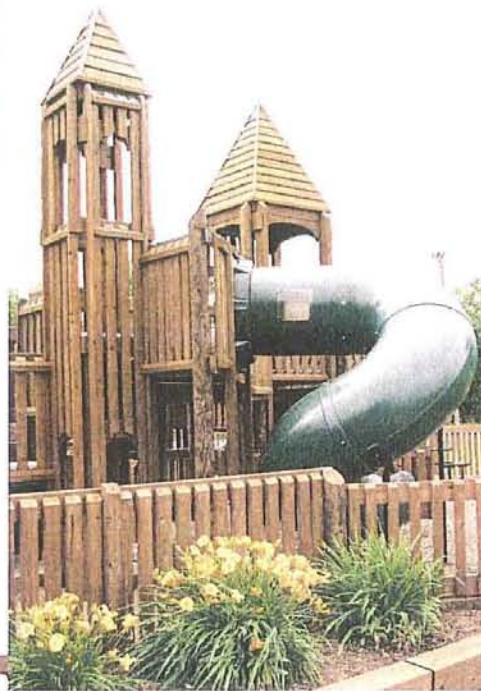
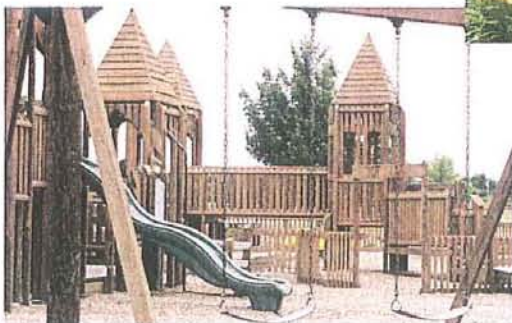
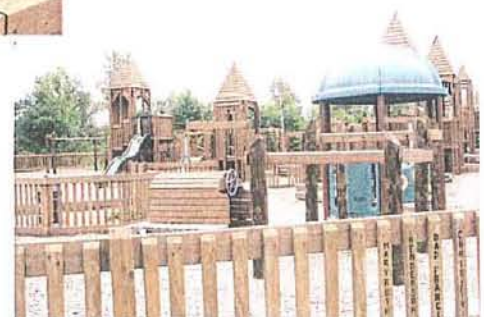
The picket fence provides safety and security for our children. A special area of the fence is designated for "In Memory of" pickets.
